General Information

Make	Mitsubishi	Model	Mirage
YOM	2023	Odo Meter Reading	24,824
Registration No.	NEE3458	Chassis No.	PAEA13TJPNA004045
CC	1.2	Transmission	A/T
Fuel Type	Gas	Type of Body	Sedan
Colour	Red

Body / Panel Condition

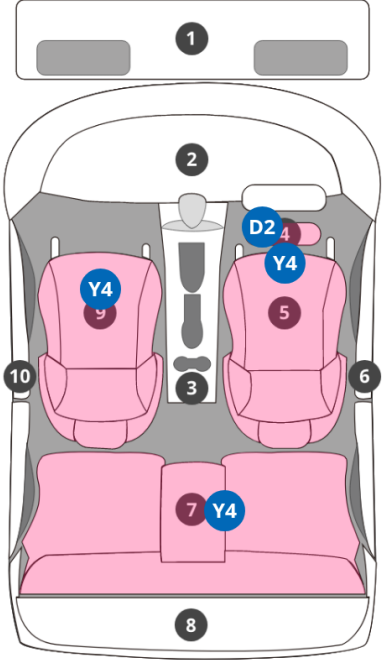
Interior Evaluation : C	Exterior Evaluation : E

<p>a : Cut, Fray d : Loose, Deformed k : Animal Hair s : Smell t : Cigarette Burns x : Defective y : Stain</p>

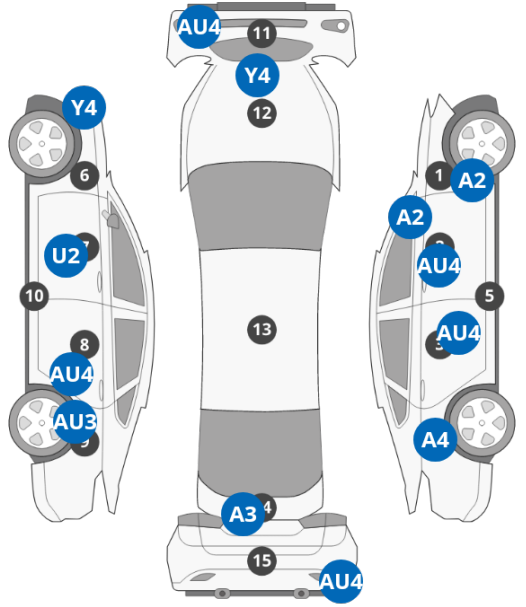
<p>A : Scratch AU : Scratch & Dent B : Modified C : Corrosion G : Stone chip P : Faded S : Rust SC : Rust & Corrosion U : Dent X : Defective Y : Crack, Gap</p>
<p>Remarks (L) Front Seat - Grime - Large / (R) Front Seat - Grime - Large / Rear Seat - Grime - Large / (L) Front Floor Mat - Worked - Small</p>	<p>Remarks (R) Front Door - Repair Traces - Yes / (R) Step - Repair Traces - Yes / (R) Front Fender - Repair Traces - Yes / Bonnet - Repair Traces - Yes / (L) Front Fender - Repair Traces - Yes / (L) Front Door - Repair Traces - Yes / (L) Step - Repair Traces - Yes / Front Bumper, Grille, Lamps - Scratch & Dent - Large / Bonnet, Headlight - Crack, Gap - Large / (L) Front Fender, Molding - Crack, Gap - Large / (L) Front Door, Molding - Dent - Small / (L) Rear Door, Molding - Scratch & Dent - Large / (L) Rear Fender, Molding - Scratch & Dent - Medium / Trunk Hood, Rear Gate - Scratch - Medium / Rear Bumper, Lamps, Panels - Scratch & Dent - Large / (R) Rear Door, Molding - Scratch & Dent - Large / (R) Rear Fender, Molding - Scratch - Large / (R) Front Door, Molding - Scratch & Dent - Large / (R) Mirror - Scratch - Small / (R) Front Fender, Molding - Scratch - Small</p>
