## General Information

<b>Make</b>	Toyota	<b>Model</b>	Vios
<b>YOM</b>	2023	<b>Odo Meter Reading</b>	34,493
<b>Registration No.</b>	NHA2381	<b>Chassis No.</b>	PA1B18F31P4215741
<b>CC</b>	1.3	<b>Transmission</b>	CVT
<b>Fuel Type</b>	Gas	<b>Type of Body</b>	Sedan
<b>Colour</b>	Green

## Body / Panel Condition

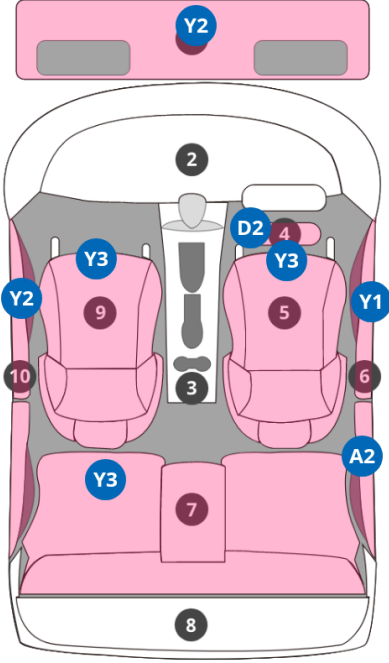
<b>Interior Evaluation :</b> <span style="float: right; color: red; font-weight: bold;">C</span>	<b>Exterior Evaluation :</b> <span style="float: right; color: red; font-weight: bold;">D</span>

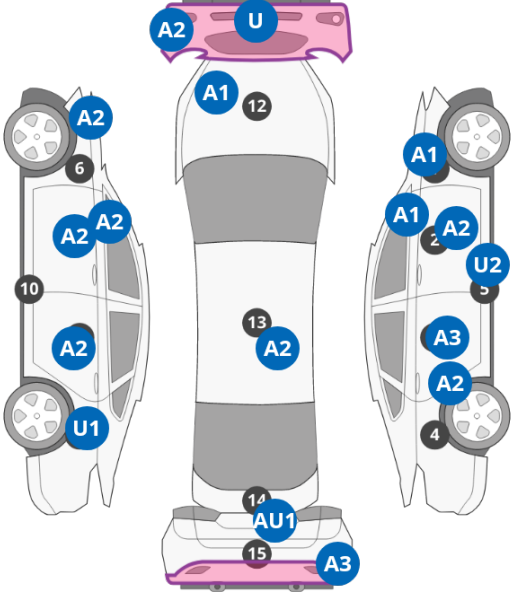
<p><b>A</b> : Scratch <b>AU</b> : Scratch &amp; Dent <b>B</b> : Modified <b>C</b> : Corrosion <b>G</b> : Stone chip <b>P</b> : Faded <b>S</b> : Rust <b>SC</b> : Rust &amp; Corrosion <b>U</b> : Dent <b>X</b> : Defective <b>Y</b> : Crack, Gap</p>
<p><b>Remarks</b> (L) Front Seat - Grime - Medium / (R) Front Seat - Grime - Medium / Rear Seat - Grime - Medium / (R) Front Trim - Grime - Minimal / (L) Front Trim - Grime - Small / Ceiling - Grime - Small / (L) Front Floor Mat - Worked - Small / (R) Rear Trim - Cut, Crack - Small</p>	<p><b>Remarks</b> (L) Front Fender - Repair Traces - Yes / (R) Rear Fender - Repair Traces - Yes / Overall Exterior - Worn as per age - Yes / Overall Exterior - Faded(Color, Gloss) - Yes / Overall Exterior - Re-Paint Uneven - Yes / Front Bumper, Grille, Lamps - Repair mark - Yes / (R) Front Fender, Molding - Scratch - Minimal / (R) Mirror - Scratch - Minimal / (R) Front Door, Molding - Scratch - Small / (R) Rear Door, Molding - Scratch - Medium / (R) Step, In-panel, Side Spoiler - Dent - Small / (R) Rear Fender, Molding - Scratch - Small / Rear Bumper, Lamps, Panels - Repair mark - Yes / Rear Bumper, Lamps, Panels - Scratch - Medium / Trunk Hood, Rear Gate - Scratch &amp; Dent - Minimal / Overall Exterior - Full Re-Paint in same color - Yes / (L) Front Door, Molding - Scratch - Small / (L) Rear Door, Molding - Scratch - Small / (L) Rear Fender, Molding - Dent - Minimal / (L) Mirror - Scratch - Small / Member (Bolted) - Dent - Yes / (L) Front Fender, Molding - Scratch - Small / Front Bumper, Grille, Lamps - Scratch - Small / Bonnet, Headlight - Scratch - Minimal / Roof - Scratch - Small</p>
