## General Information

Date & Time: 04, Feb, 2026 05:05

<b>Make</b>	Ford	<b>Model</b>	Ranger
<b>YOM</b>	2020	<b>Odo Meter Reading</b>	30,151
<b>Registration No.</b>	NGB2563	<b>Chassis No.</b>	MNCLMFF80LW080668
<b>CC</b>	2.2	<b>Transmission</b>	A/T
<b>Fuel Type</b>	Diesel	<b>Type of Body</b>	Pickup
<b>Colour</b>	Gray

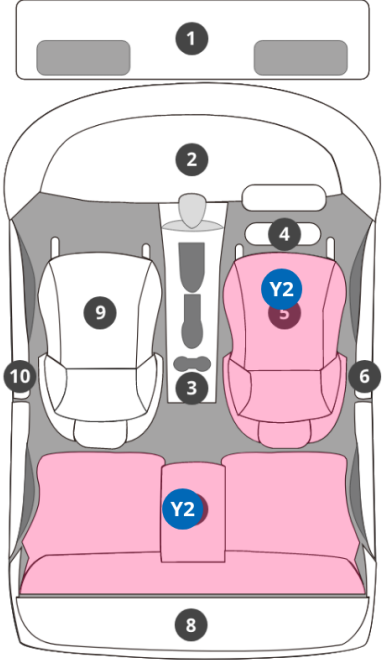
<b>Interior Evaluation :</b> <span style="color: red; font-weight: bold; font-size: 1.2em;">A</span>	<b>Exterior Evaluation :</b> <span style="color: red; font-weight: bold; font-size: 1.2em;">C</span>

<p><b>a</b> : Cut, Fray <b>d</b> : Loose, Deformed <b>k</b> : Animal Hair <b>s</b> : Smell <b>t</b> : Cigarette Burns <b>x</b> : Defective <b>y</b> : Stain</p>

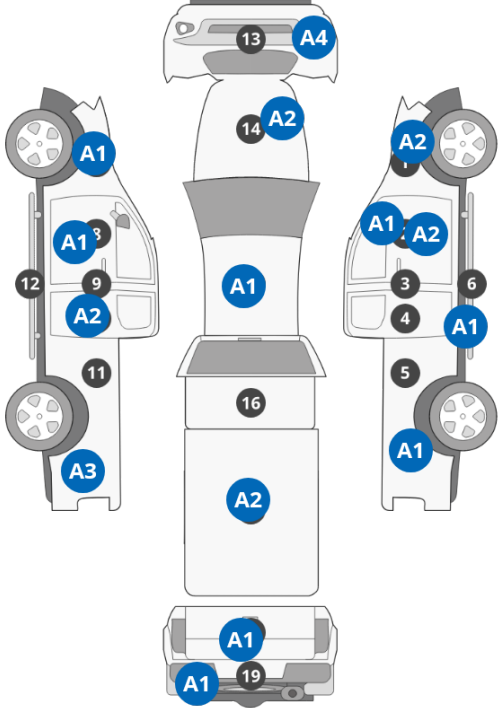
<p><b>A</b> : Scratch <b>AU</b> : Scratch &amp; Dent <b>B</b> : Modified <b>C</b> : Corrosion <b>G</b> : Stone chip <b>P</b> : Faded <b>S</b> : Rust <b>SC</b> : Rust &amp; Corrosion <b>U</b> : Dent <b>X</b> : Defective <b>Y</b> : Crack, Gap</p>
<p><b>Remarks</b> (R) Front Seat - Grime - Small / Rear Seat - Grime - Small</p>	<p><b>Remarks</b> Front Bumper, Grille, Lamps - Scratch - Large / Bonnet, Headlight - Scratch - Small / (R) Front Fender, Molding - Scratch - Small / (R) Mirror - Scratch - Minimal / (R) Front Door, Molding - Scratch - Small / (R) Step, In-panel, Side Spoiler - Scratch - Minimal / (R) Guard Frame - Scratch - Minimal / Rear Gate - Scratch - Minimal / Rear Bumper, Lamps, Panels - Scratch - Minimal / (L) Guard Frame - Scratch - Medium / (L) Rear Door, Molding - Scratch - Small / (L) Front Door, Molding - Scratch - Minimal / (L) Front Fender, Molding - Scratch - Minimal / Roof - Scratch - Minimal / Cargo Bed Floor - Scratch - Small</p>
