## General Information

| <b>Make</b> | Chevrolet | <b>Model</b> | Sail |
| <b>Registration No.</b> | NCB4929 | <b>Chassis No.</b> | LSGHD52H8GD258264 |

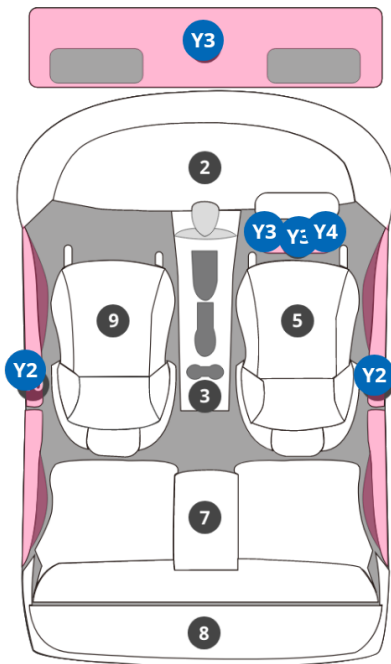
| <p><b>Remarks</b><br/>(L) Front Trim - Grime - Small / (L) Front Floor Mat - Grime - Medium / Ceiling - Grime - Medium / Mat Other - Grime - Medium / (R) Front Floor Mat - Grime - Large / (R) Front Trim - Grime - Small</p> | <p><b>Remarks</b><br/>(R) Step - Repair Traces - Yes / (R) Front Fender - Repair Traces - Yes / Bonnet - Repair Traces - Yes / (L) Front Door - Repair Traces - Yes / (L) Step - Repair Traces - Yes / (L) Rear Door - Repair Traces - Yes / (L) Rear Fender - Repair Traces - Yes / Bonnet, Headlight - Scratch &amp; Dent - Large / (L) Front Fender, Molding - Scratch &amp; Dent - Medium / (L) Mirror - Scratch - Small / Bonnet, Headlight - Repair mark - Yes / (R) Front Fender, Molding - Repair mark - Yes / (L) Front Door, Molding - Scratch - Medium / (L) Rear Door, Molding - Scratch &amp; Dent - Large / (L) Rear Fender, Molding - Scratch &amp; Dent - Large / Trunk Hood, Rear Gate - Scratch - Small / Rear Bumper, Lamps, Panels - Scratch &amp; Dent - Large / Member (Bolted) - Dent - Yes / Front Bumper, Grille, Lamps - Scratch &amp; Dent - Large / (R) Front Fender, Molding - Scratch - Small / (R) Mirror - Scratch - Medium / (R) Front Door, Molding - Scratch - Large / (R) Rear Door, Molding - Scratch &amp; Dent - Medium / (R) Rear Fender, Molding - Scratch &amp; Dent - Medium / (L) Step, In-panel, Side Spoiler - Scratch &amp; Dent - Large / Roof - Scratch &amp; Dent - Small</p> |
