General Information

Date & Time: 05, Feb, 2026 12:12

Make	Suzuki	Model	Ertiga
YOM	2024	Odo Meter Reading	20,081
Registration No.	NNV4967	Chassis No.	MHYNC3250RJ103780
CC	1.5	Transmission	A/T
Fuel Type	Hybrid	Type of Body	Wagon
Colour	Red

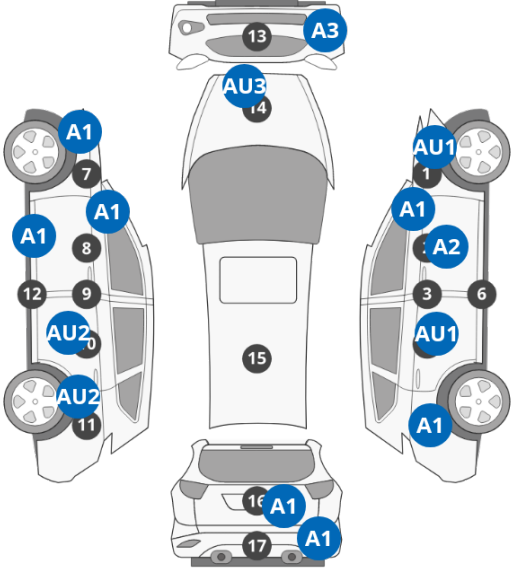
<p>A : Scratch AU : Scratch & Dent B : Modified C : Corrosion G : Stone chip P : Faded S : Rust SC : Rust & Corrosion U : Dent X : Defective Y : Crack, Gap</p>
<p>Remarks Defects not found</p>	<p>Remarks (R) Front Fender, Molding - Scratch & Dent - Minimal / (R) Mirror - Scratch - Minimal / (R) Front Door, Molding - Scratch - Small / (R) Rear Door, Molding - Scratch & Dent - Minimal / (R) Rear Fender, Molding - Scratch - Minimal / Trunk Hood, Rear Gate - Scratch - Minimal / Rear Bumper, Lamps, Panels - Scratch - Minimal / (L) Rear Fender, Molding - Scratch & Dent - Small / (L) Rear Door, Molding - Scratch & Dent - Small / (L) Step, In-panel, Side Spoiler - Scratch - Minimal / (L) Mirror - Scratch - Minimal / (L) Front Fender, Molding - Scratch - Minimal / Front Bumper, Grille, Lamps - Scratch - Medium / Bonnet, Headlight - Scratch & Dent - Medium</p>
