General Information

Make	Suzuki	Model	APV
YOM	2025	Odo Meter Reading	5,845
Registration No.	NKM7104	Chassis No.	MHYDN71V7SJ401026
CC	1.6	Transmission	M/T
Fuel Type	Gas	Type of Body	Van
Colour	Red

Body / Panel Condition

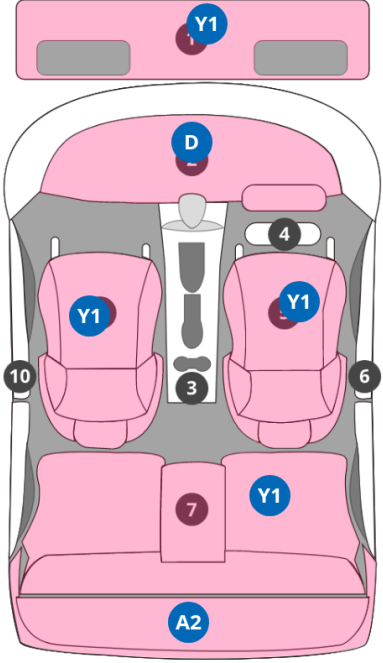
Interior Evaluation : A	Exterior Evaluation : C

<p>a : Cut, Fray d : Loose, Deformed k : Animal Hair s : Smell t : Cigarette Burns x : Defective y : Stain</p>

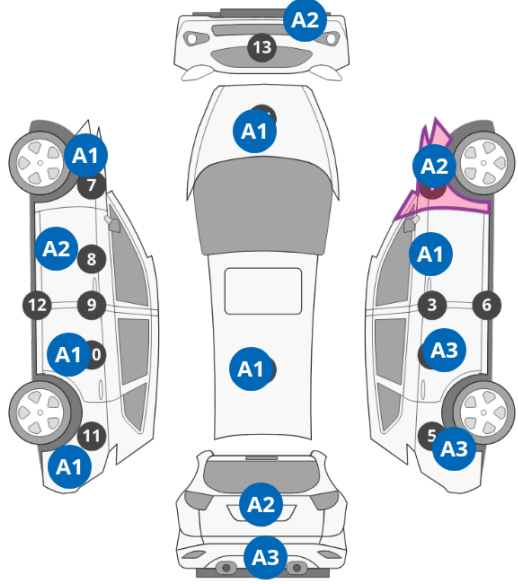
<p>A : Scratch AU : Scratch & Dent B : Modified C : Corrosion G : Stone chip P : Faded S : Rust SC : Rust & Corrosion U : Dent X : Defective Y : Crack, Gap</p>
<p>Remarks Dashboard - Traces of Adhesive Tape - Yes / Ceiling - Grime - Minimal / Trunk Room - Worn, Scratch, Cut, Crack - Small / (R) Front Seat - Grime - Minimal / Rear Seat - Grime - Minimal / (L) Front Seat - Grime - Minimal</p>	<p>Remarks (R) Front Fender - Repair Traces - Yes / (R) Front Fender, Molding - Repair mark - Yes / (L) Front Door, Molding - Scratch - Small / Front Bumper, Grille, Lamps - Scratch - Small / Bonnet, Headlight - Scratch - Minimal / (R) Front Fender, Molding - Scratch - Small / (R) Rear Door, Molding - Scratch - Medium / (R) Front Door, Molding - Scratch - Minimal / (R) Rear Fender, Molding - Scratch - Medium / Rear Bumper, Lamps, Panels - Scratch - Medium / Trunk Hood, Rear Gate - Scratch - Small / (L) Rear Fender, Molding - Scratch - Minimal / (L) Rear Door, Molding - Scratch - Minimal / (L) Front Fender, Molding - Scratch - Minimal / Roof - Scratch - Minimal</p>
