## General Information

| Make | Toyota | Model | Vios |
| Registration No. | CBL6814 | Chassis No. | PA1B18F34M4134468 |

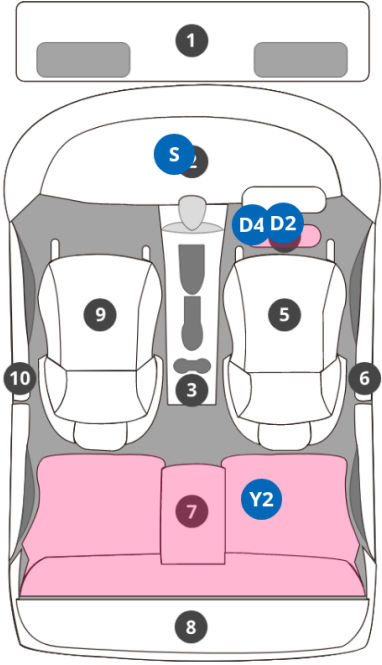
| Interior Evaluation : <span>C</span> | Exterior Evaluation : <span>C</span> |
|---|---|
| <b>Remarks</b><br>Rear Seat - Grime - Small / (L) Front Floor Mat - Worked - Large / Overall Interior - Smell - Yes / (R) Front Floor Mat - Worked - Small | <b>Remarks</b><br>Front Bumper, Grille, Lamps - Scratch - Medium / (L) Rear Fender, Molding - Scratch & Dent - Minimal / Trunk Hood, Rear Gate - Dent - Minimal / (R) Rear Fender, Molding - Scratch & Dent - Medium / (R) Front Door, Molding - Dent - Small / Rear Bumper, Lamps, Panels - Scratch - Medium / Roof - Dent - Small / (L) Rear Door, Molding - Dent - Minimal / (L) Front Door, Molding - Scratch - Small |
