## General Information

Date & Time: 07, Feb, 2026 14:17

<b>Make</b>	Toyota	<b>Model</b>	Avanza
<b>YOM</b>	2025	<b>Odo Meter Reading</b>	42,208
<b>Registration No.</b>	NJF5158	<b>Chassis No.</b>	MHFAA1BY1S0040556
<b>CC</b>	1.3	<b>Transmission</b>	CVT
<b>Fuel Type</b>	Gas	<b>Type of Body</b>	Wagon
<b>Colour</b>	Green

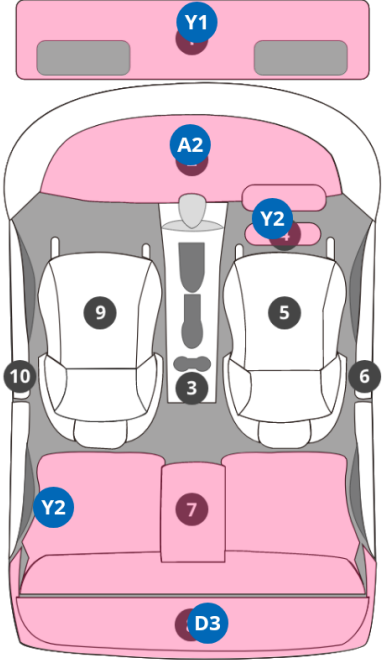
<b>Interior Evaluation :</b> <span style="float: right; color: red; font-weight: bold;">B</span>	<b>Exterior Evaluation :</b> <span style="float: right; color: red; font-weight: bold;">C</span>

<p><b>a</b> : Cut, Fray <b>d</b> : Loose, Deformed <b>k</b> : Animal Hair <b>s</b> : Smell <b>t</b> : Cigarette Burns <b>x</b> : Defective <b>y</b> : Stain</p>

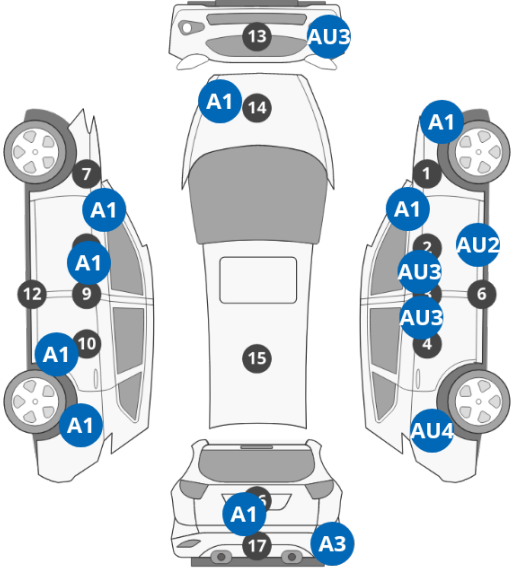
<p><b>A</b> : Scratch <b>AU</b> : Scratch &amp; Dent <b>B</b> : Modified <b>C</b> : Corrosion <b>G</b> : Stone chip <b>P</b> : Faded <b>S</b> : Rust <b>SC</b> : Rust &amp; Corrosion <b>U</b> : Dent <b>X</b> : Defective <b>Y</b> : Crack, Gap</p>
<p><b>Remarks</b> Ceiling - Grime - Minimal / (L) Front Floor Mat - Grime - Small / Trunk Room - Loose, Deformed - Medium / Rear Seat - Grime - Small / Steering Wheel - Worn, Peel, Crack - Small</p>	<p><b>Remarks</b> (R) Front Fender, Molding - Scratch - Minimal / (R) Mirror - Scratch - Minimal / (R) Front Door, Molding - Scratch &amp; Dent - Medium / (R) Rear Door, Molding - Scratch &amp; Dent - Medium / (R) Step, In-panel, Side Spoiler - Scratch &amp; Dent - Small / (R) Rear Fender, Molding - Scratch &amp; Dent - Large / Rear Bumper, Lamps, Panels - Scratch - Medium / Trunk Hood, Rear Gate - Scratch - Minimal / (L) Rear Fender, Molding - Scratch - Minimal / (L) Rear Door, Molding - Scratch - Minimal / (L) Front Door, Molding - Scratch - Minimal / (L) Mirror - Scratch - Minimal / Bonnet, Headlight - Scratch - Minimal / Front Bumper, Grille, Lamps - Scratch &amp; Dent - Medium</p>
