## General Information

<b>Make</b>	MG	<b>Model</b>	MG 5
<b>YOM</b>	2025	<b>Odo Meter Reading</b>	7,522
<b>Registration No.</b>	NKO4579	<b>Chassis No.</b>	LSJA36E3S7SZ616003
<b>CC</b>	1.5	<b>Transmission</b>	CVT
<b>Fuel Type</b>	Gas	<b>Type of Body</b>	Sedan
<b>Colour</b>	Silver

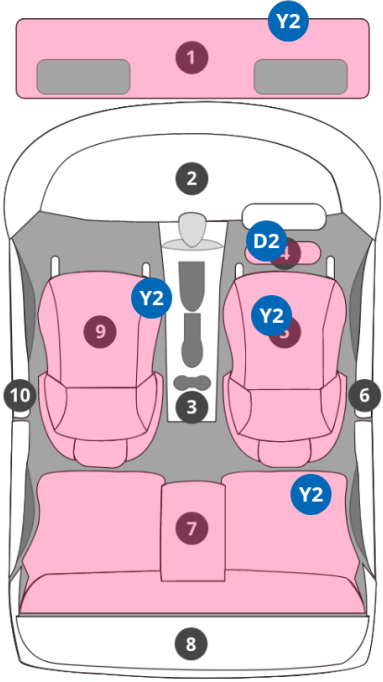
<b>Interior Evaluation :</b> <span style="float: right;"><b>B</b></span>	<b>Exterior Evaluation :</b> <span style="float: right;"><b>B</b></span>

<p><b>a</b> : Cut, Fray <b>d</b> : Loose, Deformed <b>k</b> : Animal Hair <b>s</b> : Smell <b>t</b> : Cigarette Burns <b>x</b> : Defective <b>y</b> : Stain</p>

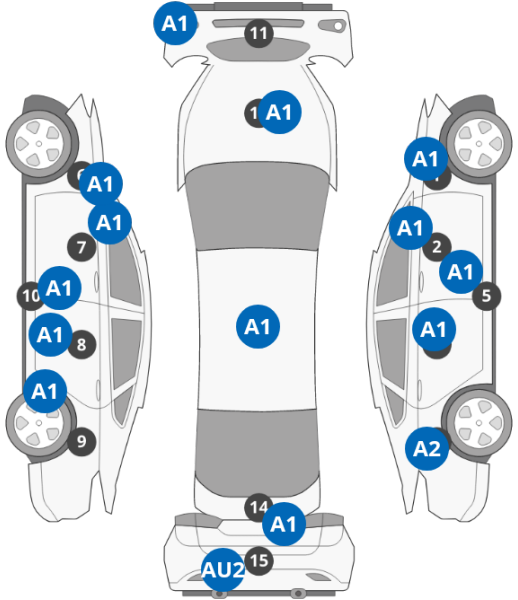
<p><b>A</b> : Scratch <b>AU</b> : Scratch &amp; Dent <b>B</b> : Modified <b>C</b> : Corrosion <b>G</b> : Stone chip <b>P</b> : Faded <b>S</b> : Rust <b>SC</b> : Rust &amp; Corrosion <b>U</b> : Dent <b>X</b> : Defective <b>Y</b> : Crack, Gap</p>
<p><b>Remarks</b> (L) Front Floor Mat - Worked - Small / (R) Front Seat - Grime - Small / (L) Front Seat - Grime - Small / Ceiling - Grime - Small / Rear Seat - Grime - Small</p>	<p><b>Remarks</b> (R) Front Fender, Molding - Scratch - Minimal / (R) Mirror - Scratch - Minimal / (R) Front Door, Molding - Scratch - Minimal / (R) Rear Door, Molding - Scratch - Minimal / (R) Rear Fender, Molding - Scratch - Small / Rear Bumper, Lamps, Panels - Scratch &amp; Dent - Small / Trunk Hood, Rear Gate - Scratch - Minimal / (L) Rear Fender, Molding - Scratch - Minimal / (L) Rear Door, Molding - Scratch - Minimal / (L) Front Door, Molding - Scratch - Minimal / (L) Mirror - Scratch - Minimal / (L) Front Fender, Molding - Scratch - Minimal / Front Bumper, Grille, Lamps - Scratch - Minimal / Roof - Scratch - Minimal / Bonnet, Headlight - Scratch - Minimal</p>
