## General Information

Date & Time: 12, Feb, 2026 18:57

<b>Make</b>	Mitsubishi	<b>Model</b>	L300
<b>YOM</b>	2017	<b>Odo Meter Reading</b>	131,804
<b>Registration No.</b>	IAB5880	<b>Chassis No.</b>	PAEA65NYHHB04466
<b>CC</b>	2.5	<b>Transmission</b>	M/T
<b>Fuel Type</b>	Diesel	<b>Type of Body</b>	Utility Vehicle
<b>Colour</b>	White

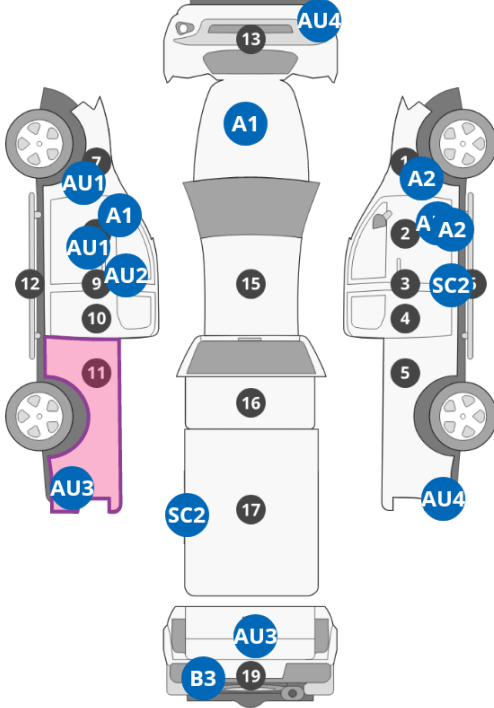
<p><b>A</b> : Scratch <b>AU</b> : Scratch &amp; Dent <b>B</b> : Modified <b>C</b> : Corrosion <b>G</b> : Stone chip <b>P</b> : Faded <b>S</b> : Rust <b>SC</b> : Rust &amp; Corrosion <b>U</b> : Dent <b>X</b> : Defective <b>Y</b> : Crack, Gap</p>
<p><b>Remarks</b> Carpet - Worn, Scratch, Cut, Crack - Medium / Ceiling - Loose, Deformed - Medium / (L) Front Trim - Loose, Deformed - Medium / Overall Interior - Worn as per age - Yes / Glove Box - Worn, Scratch, Cut, Crack - Small / Rear Seat - Missing - Yes / (R) Front Trim - Grime - Small / Console, Switchs, Vents - Loose, Deformed - Medium</p>	<p><b>Remarks</b> (R) Rear Corner Panel - Repair Traces - Yes / (R) Front Fender, Molding - Scratch - Small / (R) Front Door, Molding - Scratch &amp; Dent - Small / (R) Center Panel - Rust, Corrosion - Small / (R) Step, In-panel, Side Spoiler - Scratch - Small / (R) Side Gate - Scratch &amp; Dent - Large / Rear Bumper, Lamps, Panels - Modified - Medium / Rear Gate - Scratch &amp; Dent - Medium / Roof - Rust, Corrosion - Small / (L) Side Gate - Repair mark - Difference in Color / (L) Side Gate - Scratch &amp; Dent - Medium / (L) Center Panel - Scratch &amp; Dent - Small / (L) Mirror - Scratch - Minimal / (L) Front Door, Molding - Scratch &amp; Dent - Minimal / (L) Front Fender, Molding - Scratch &amp; Dent - Minimal / Front Bumper, Grille, Lamps - Scratch &amp; Dent - Large / Front Panel - Scratch - Minimal</p>
