General Information

Make	Suzuki	Model	XL7
YOM	2025	Odo Meter Reading	12,776
Registration No.	GBK9480	Chassis No.	MHYNC32S8TJ100211
CC	1.5	Transmission	A/T
Fuel Type	Gas	Type of Body	Wagon
Colour	Orange

Body / Panel Condition

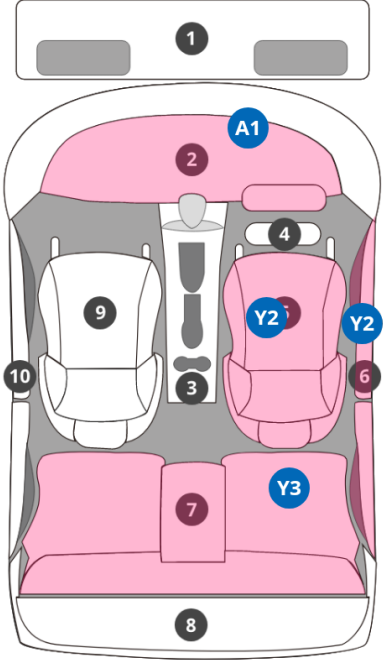
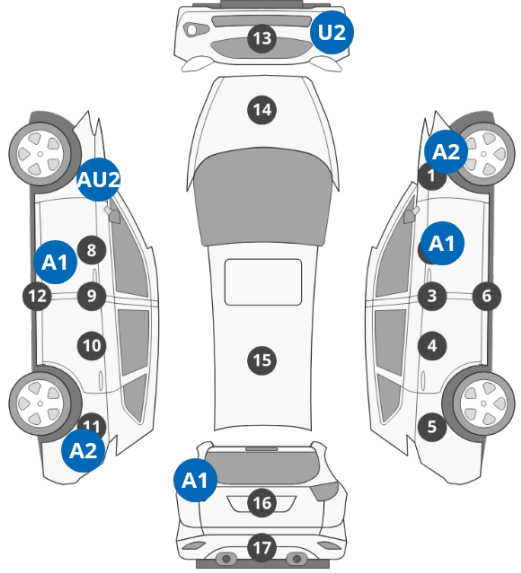
Interior Evaluation :	B	Exterior Evaluation :	B

<p>a : Cut, Fray d : Loose, Deformed k : Animal Hair s : Smell t : Cigarette Burns x : Defective y : Stain</p>		<p>A : Scratch AU : Scratch & Dent B : Modified C : Corrosion G : Stone chip P : Faded S : Rust SC : Rust & Corrosion U : Dent X : Defective Y : Crack, Gap</p>	
<p>Remarks (R) Front Seat - Grime - Small / Rear Seat - Grime - Medium / (R) Front Trim - Grime - Small / Dashboard - Worn, Scratch, Cut, Crack - Minimal</p>		<p>Remarks Trunk Hood, Rear Gate - Repair Traces - Yes / Roof - Repair Traces - Yes / (R) Front Fender, Molding - Scratch - Small / Front Bumper, Grille, Lamps - Dent - Small / (R) Front Door, Molding - Scratch - Minimal / Trunk Hood, Rear Gate - Scratch - Minimal / (L) Rear Fender, Molding - Scratch - Small / (L) Rear Door, Molding - Scratch - Minimal / (L) Front Fender, Molding - Scratch & Dent - Small</p>	
Frame Evaluation :	A	Functional Evaluation :	A
