General Information

| Make | Toyota | Model | Vios |
| YOM | 2025 | Odo Meter Reading | 47,623 |
| Registration No. | DBR1285 | Chassis No. | PA1B18F33R4275992 |

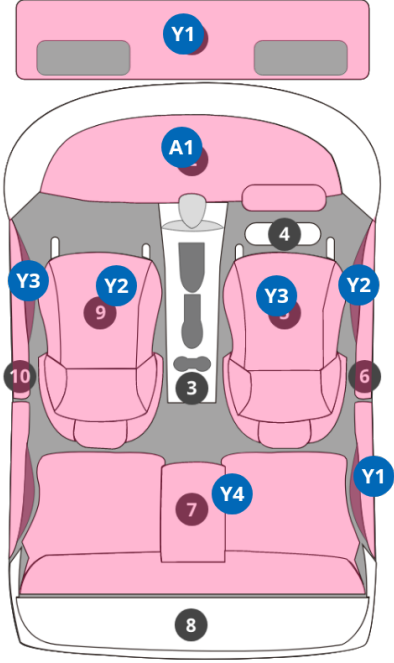
| Interior Evaluation : C | Exterior Evaluation : C |
| <p>Remarks (R) Front Seat - Grime - Medium / (R) Front Trim - Grime - Small / Rear Seat - Grime - Large / (R) Rear Trim - Grime - Minimal / (L) Front Trim - Grime - Medium / (L) Front Seat - Grime - Small / Ceiling - Grime - Minimal / Dashboard - Worn, Scratch, Cut, Crack - Minimal</p> | <p>Remarks Roof - Scratch - Small / (L) Front Door, Molding - Scratch & Dent - Small / (L) Rear Door, Molding - Scratch - Minimal / (L) Mirror - Scratch - Minimal / Bonnet, Headlight - Scratch - Small / Front Bumper, Grille, Lamps - Scratch - Medium / (R) Front Fender, Molding - Scratch & Dent - Medium / (R) Front Door, Molding - Scratch & Dent - Small / (R) Rear Door, Molding - Scratch - Medium / (R) Rear Fender, Molding - Scratch - Medium / Trunk Hood, Rear Gate - Scratch - Minimal / Rear Bumper, Lamps, Panels - Scratch - Small / (L) Rear Fender, Molding - Scratch - Minimal / (L) Front Fender, Molding - Scratch - Minimal</p> |
