General Information

| Make | Toyota | Model | Vios |
| Registration No. | NHM3823 | Chassis No. | PA1B18F39R4238980 |

Body / Panel Condition

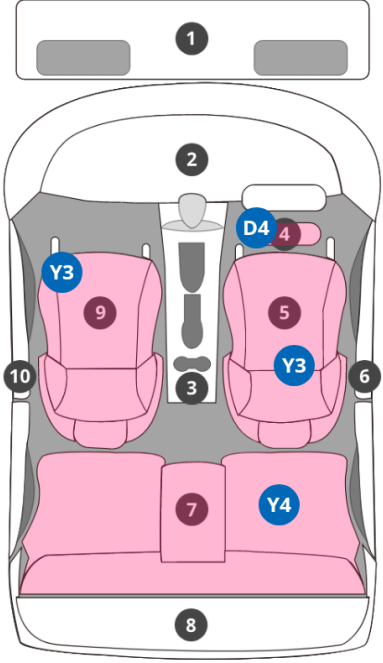
| Interior Evaluation : | C | Exterior Evaluation : | E |

| <p>Remarks Rear Seat - Grime - Large / (R) Front Seat - Grime - Medium / (L) Front Seat - Grime - Medium / (L) Front Floor Mat - Worked - Large</p> | | <p>Remarks (R) Step - Repair Traces - Yes / Bonnet - Repair Traces - Yes / (L) Step - Repair Traces - Yes / Trunk Hood, Rear Gate - Repair Traces - Yes / (R) Front Fender, Molding - Scratch & Dent - Large / Front Bumper, Grille, Lamps - Scratch & Dent - Large / Bonnet, Headlight - Scratch - Large / (L) Front Fender, Molding - Scratch - Large / (L) Front Door, Molding - Scratch - Large / (L) Rear Door, Molding - Scratch - Large / (L) Rear Fender, Molding - Scratch - Large / (L) Step, In-panel, Side Spoiler - Scratch - Medium / Rear Bumper, Lamps, Panels - Scratch - Large / Trunk Hood, Rear Gate - Dent - Small / (R) Rear Fender, Molding - Scratch - Large / (R) Rear Door, Molding - Scratch & Dent - Large / (R) Step, In-panel, Side Spoiler - Scratch & Dent - Small / (R) Front Door, Molding - Scratch - Large / Roof - Scratch - Small</p> | |
