## General Information

<b>Make</b>	Toyota	<b>Model</b>	Avanza
<b>YOM</b>	2025	<b>Odo Meter Reading</b>	30,808
<b>Registration No.</b>	NJA5579 - NON-MOVING	<b>Chassis No.</b>	MHFAA1BYOR0037609
<b>CC</b>	1.3	<b>Transmission</b>	CVT
<b>Fuel Type</b>	Gas	<b>Type of Body</b>	MPV
<b>Colour</b>	Black

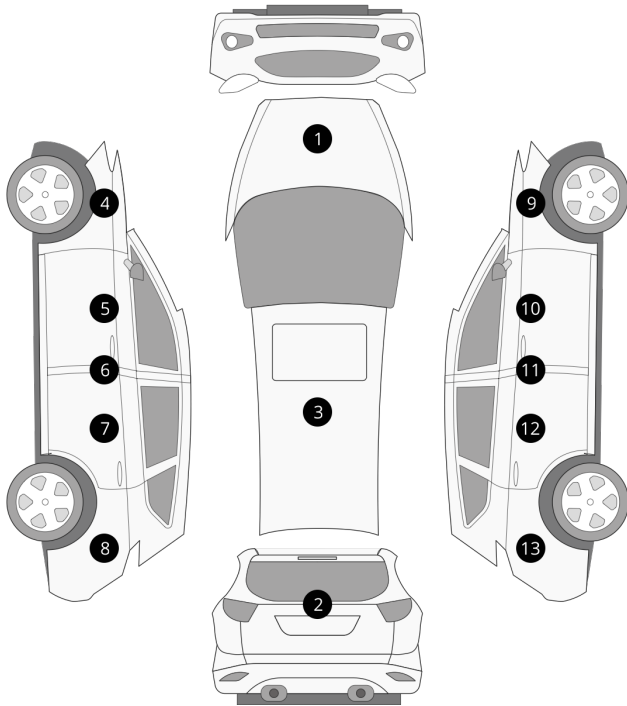
## Body / Panel Condition

#	Area	Thickness(um)			
		Average	Value1	Value2	Value3/4
1	Bonnet	118.0	117	108	129
2	Boot Lid	101.8	104	105	97
3	Roof	129.5	130	136	139/113
4	Left Front Fender	105.3	107	106	103
5	Left Front Door	116.6	105	119	126
6	Center Panel Left				
7	Left Rear Door	115.0	120	108	117
8	Left Back Panel	110.5	123	109	100
9	Right Front Fender	106.0	107	111	100
10	Right Front Door	113.6	117	114	110
11	Center Panel Right				
12	Right Rear Door	116.3	125	106	118
13	Right Back Panel	111.3	112	105	117

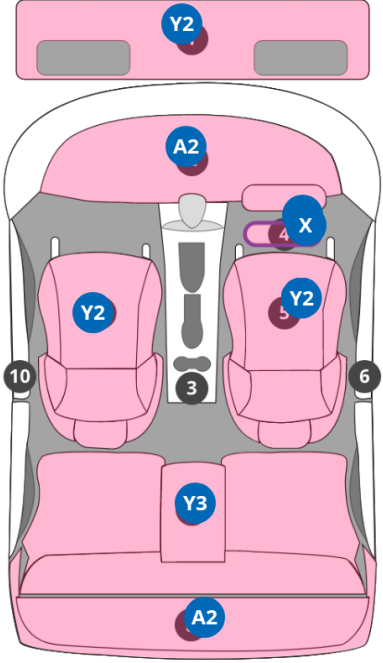
<b>Interior Evaluation :</b> <span style="float: right;"><b>B</b></span>	<b>Exterior Evaluation :</b> <span style="float: right;"><b>C</b></span>

<p><b>A</b> : Scratch <b>AU</b> : Scratch &amp; Dent <b>B</b> : Modified <b>C</b> : Corrosion <b>G</b> : Stone chip <b>P</b> : Faded <b>S</b> : Rust <b>SC</b> : Rust &amp; Corrosion <b>U</b> : Dent <b>X</b> : Defective <b>Y</b> : Crack, Gap</p>
<p><b>Remarks</b> (R) Front Seat - Grime - Small / Dashboard - Worn, Scratch, Cut, Crack - Small / Rear Seat - Grime - Medium / Trunk Room - Worn, Scratch, Cut, Crack - Small / (R) Front Floor Mat - Missing - Yes / Mat Other - Missing - Yes / Ceiling - Grime - Small / (L) Front Seat - Grime - Small</p>	<p><b>Remarks</b> (R) Rear Door, Molding - Scratch &amp; Dent - Small / Front Bumper, Grille, Lamps - Scratch - Medium / (R) Front Fender, Molding - Scratch - Small / (R) Front Door, Molding - Scratch - Small / (R) Rear Fender, Molding - Scratch - Small / Trunk Hood, Rear Gate - Scratch - Small / Rear Bumper, Lamps, Panels - Scratch - Small / Roof - Scratch - Small / (L) Rear Fender, Molding - Scratch - Small / (L) Rear Door, Molding - Scratch - Small / (L) Front Door, Molding - Scratch - Small / Bonnet, Headlight - Scratch - Small / (L) Front Fender, Molding - Scratch - Small</p>
