## General Information

<b>Make</b>	Toyota	<b>Model</b>	Vios
<b>YOM</b>	2025	<b>Odo Meter Reading</b>	41,776
<b>Registration No.</b>	NKJ9899	<b>Chassis No.</b>	PA1B18F38R4267564
<b>CC</b>	1.3	<b>Transmission</b>	CVT
<b>Fuel Type</b>	Gas	<b>Type of Body</b>	Sedan
<b>Colour</b>	Black

## Body / Panel Condition

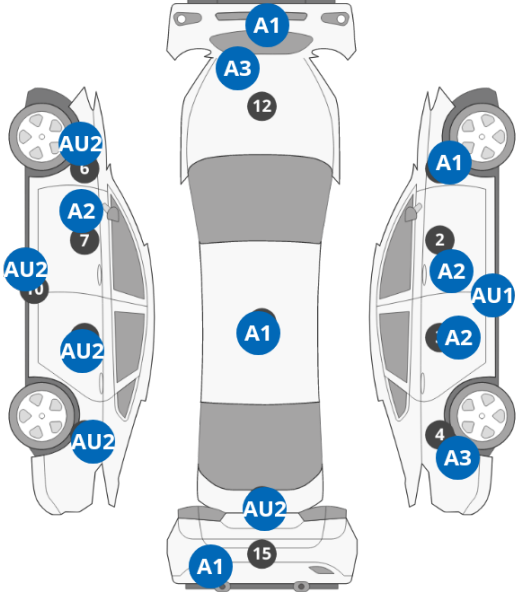
<p><b>A</b> : Scratch <b>AU</b> : Scratch &amp; Dent <b>B</b> : Modified <b>C</b> : Corrosion <b>G</b> : Stone chip <b>P</b> : Faded <b>S</b> : Rust <b>SC</b> : Rust &amp; Corrosion <b>U</b> : Dent <b>X</b> : Defective <b>Y</b> : Crack, Gap</p>
<p><b>Remarks</b> (L) Front Floor Mat - Grime - Small / (R) Front Floor Mat - Grime - Small / (L) Front Seat - Grime - Small / (R) Front Seat - Grime - Medium / Rear Seat - Grime - Medium / (L) Front Trim - Grime - Small / (R) Front Trim - Grime - Small / Ceiling - Grime - Small</p>	<p><b>Remarks</b> Bonnet, Headlight - Scratch - Medium / (L) Front Door, Molding - Scratch - Small / (L) Front Fender, Molding - Scratch &amp; Dent - Small / (L) Rear Door, Molding - Scratch &amp; Dent - Small / (L) Step, In-panel, Side Spoiler - Scratch &amp; Dent - Small / (L) Rear Fender, Molding - Scratch &amp; Dent - Small / Trunk Hood, Rear Gate - Scratch &amp; Dent - Small / (R) Rear Fender, Molding - Scratch - Medium / Rear Bumper, Lamps, Panels - Scratch - Minimal / (R) Rear Door, Molding - Scratch - Small / (R) Front Door, Molding - Scratch - Small / (R) Step, In-panel, Side Spoiler - Scratch &amp; Dent - Minimal / (R) Front Fender, Molding - Scratch - Minimal / Roof - Scratch - Minimal / Front Bumper, Grille, Lamps - Scratch - Minimal</p>
