General Information

| Make | Toyota | Model | Wigo |

Body / Panel Condition

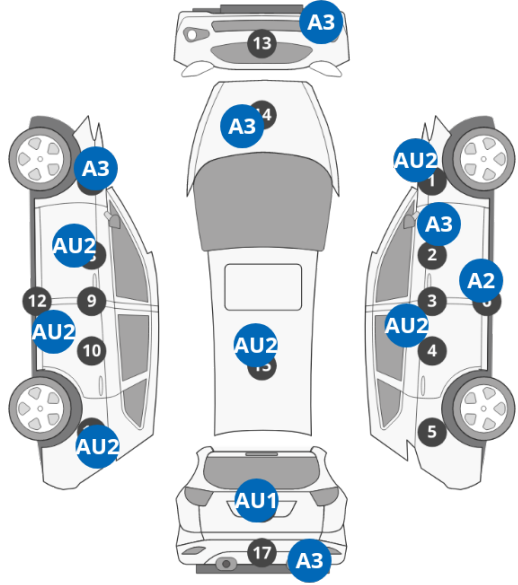
| <p>Remarks (L) Front Seat - Grime - Small / (R) Front Seat - Grime - Minimal / Rear Seat - Grime - Minimal / (L) Front Trim - Grime - Small / (R) Front Trim - Grime - Small / Ceiling - Grime - Small</p> | <p>Remarks Trunk Hood, Rear Gate - Scratch & Dent - Minimal / Rear Bumper, Lamps, Panels - Scratch - Medium / (L) Rear Fender, Molding - Scratch & Dent - Small / (L) Rear Door, Molding - Scratch & Dent - Small / (L) Front Door, Molding - Scratch & Dent - Small / Roof - Scratch & Dent - Small / (L) Front Fender, Molding - Scratch - Medium / Bonnet, Headlight - Scratch - Medium / Front Bumper, Grille, Lamps - Scratch - Medium / (R) Front Fender, Molding - Scratch & Dent - Small / (R) Front Door, Molding - Scratch - Medium / (R) Rear Door, Molding - Scratch & Dent - Small / (R) Step, In-panel, Side Spoiler - Scratch - Small</p> |

| <p>with LTO plate, with spare tire, with manual and warranty booklet, with reverse camera, no spare key, no tools and jack, scratches on taillight and headlight.</p> |
