## General Information

Date & Time: 18, Feb, 2026 15:43

<b>Make</b>	Toyota	<b>Model</b>	Innova
<b>YOM</b>	2024	<b>Odo Meter Reading</b>	106,927
<b>Registration No.</b>	DBJ9245	<b>Chassis No.</b>	PA2JA8EMXP0131149
<b>CC</b>	2.8	<b>Transmission</b>	A/T
<b>Fuel Type</b>	Diesel	<b>Type of Body</b>	Wagon
<b>Colour</b>	Red

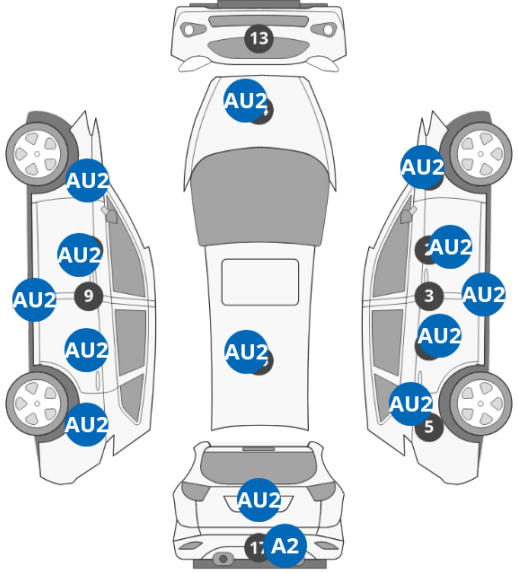
<p><b>A</b> : Scratch <b>AU</b> : Scratch &amp; Dent <b>B</b> : Modified <b>C</b> : Corrosion <b>G</b> : Stone chip <b>P</b> : Faded <b>S</b> : Rust <b>SC</b> : Rust &amp; Corrosion <b>U</b> : Dent <b>X</b> : Defective <b>Y</b> : Crack, Gap</p>
<p><b>Remarks</b> (R) Front Seat - Grime - Medium / (L) Front Seat - Grime - Small / (L) Front Trim - Grime - Medium / (L) Front Floor Mat - Grime - Medium / (R) Front Floor Mat - Grime - Medium / Rear Seat - Grime - Small / (R) Front Trim - Grime - Small / Trim Other - Loose, Deformed - Medium / Ceiling - Grime - Small / Console, Switches, Vents - Worked - Minimal</p>	<p><b>Remarks</b> (R) Front Fender - Repair Traces - Yes / (L) Front Fender - Repair Traces - Yes / (R) Front Door, Molding - Scratch &amp; Dent - Small / (R) Rear Door, Molding - Scratch &amp; Dent - Small / (R) Rear Fender, Molding - Scratch &amp; Dent - Small / Trunk Hood, Rear Gate - Scratch &amp; Dent - Small / Rear Bumper, Lamps, Panels - Scratch - Small / (L) Rear Fender, Molding - Scratch &amp; Dent - Small / (L) Rear Door, Molding - Scratch &amp; Dent - Small / (L) Front Door, Molding - Scratch &amp; Dent - Small / (L) Step, In-panel, Side Spoiler - Scratch &amp; Dent - Small / (L) Front Fender, Molding - Scratch &amp; Dent - Small / Bonnet, Headlight - Scratch &amp; Dent - Small / Roof - Scratch &amp; Dent - Small / (R) Front Fender, Molding - Scratch &amp; Dent - Small / (R) Step, In-panel, Side Spoiler - Scratch &amp; Dent - Small</p>
