General Information

Make	Toyota	Model	Vios
YOM	2024	Odo Meter Reading	28,771
Registration No.	DBM1593	Chassis No.	PA1B18F30R4241296
CC	1.3	Transmission	CVT
Fuel Type	Gas	Type of Body	Sedan
Colour	Black

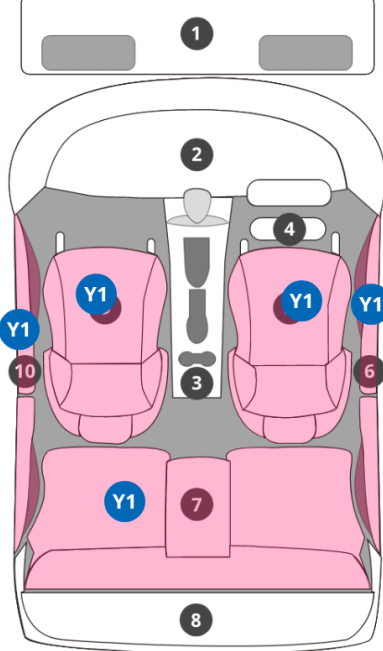
Interior Evaluation : A	Exterior Evaluation : E

<p>a : Cut, Fray d : Loose, Deformed k : Animal Hair s : Smell t : Cigarette Burns x : Defective y : Stain</p>

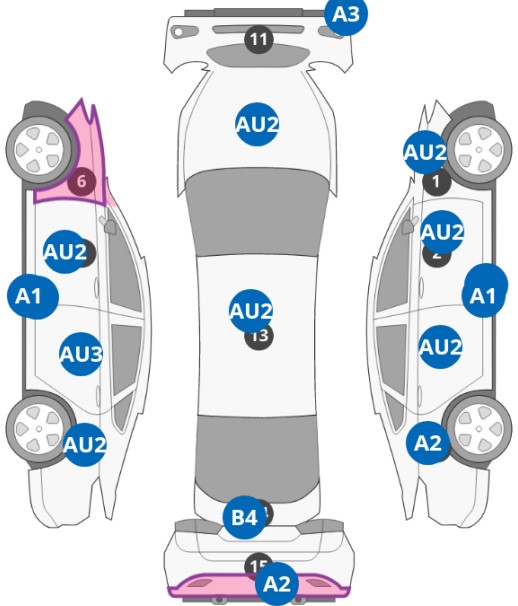
<p>A : Scratch AU : Scratch & Dent B : Modified C : Corrosion G : Stone chip P : Faded S : Rust SC : Rust & Corrosion U : Dent X : Defective Y : Crack, Gap</p>
<p>Remarks (L) Front Seat - Grime - Minimal / (R) Front Seat - Grime - Minimal / Rear Seat - Grime - Minimal / (L) Front Trim - Grime - Minimal / (R) Front Trim - Grime - Minimal</p>	<p>Remarks (R) Front Fender - Repair Traces - Yes / (L) Front Fender - Repair Traces - Yes / (L) Front Door - Repair Traces - Yes / (L) Rear Fender - Repair Traces - Yes / Trunk Hood, Rear Gate - Repair Traces - Yes / (L) Step, In-panel, Side Spoiler - Modified - Medium / Rear Bumper, Lamps, Panels - Scratch - Small / Trunk Hood, Rear Gate - Modified - Large / (R) Step, In-panel, Side Spoiler - Modified - Medium / (R) Rear Fender, Molding - Scratch - Small / Roof - Scratch & Dent - Small / (R) Rear Door, Molding - Scratch & Dent - Small / (R) Front Door, Molding - Scratch & Dent - Small / (R) Front Fender, Molding - Scratch & Dent - Small / Bonnet, Headlight - Scratch & Dent - Small / (L) Front Fender, Molding - Repair mark - Yes / (L) Front Door, Molding - Scratch & Dent - Small / Front Bumper, Grille, Lamps - Scratch - Medium / (L) Rear Door, Molding - Scratch & Dent - Medium / (L) Rear Fender, Molding - Scratch & Dent - Small / (L) Step, In-panel, Side Spoiler - Scratch - Minimal / (R) Step, In-panel, Side Spoiler - Scratch - Minimal / Rear Bumper, Lamps, Panels - Repair mark - Yes</p>
