## General Information

<b>Make</b>	Toyota	<b>Model</b>	Vios
<b>YOM</b>	2025	<b>Odo Meter Reading</b>	28,170
<b>Registration No.</b>	DBP5756	<b>Chassis No.</b>	PA1B18F38R4262784
<b>CC</b>	1.3	<b>Transmission</b>	CVT
<b>Fuel Type</b>	Gas	<b>Type of Body</b>	Sedan
<b>Colour</b>	Red Mica Metallic

## Body / Panel Condition

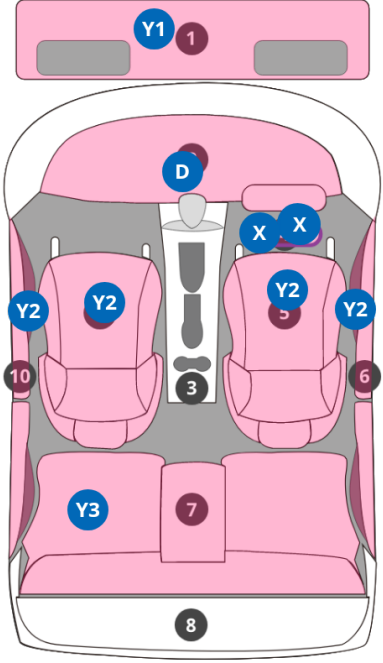
<b>Interior Evaluation :</b> <span style="float: right;"><b>B</b></span>	<b>Exterior Evaluation :</b> <span style="float: right;"><b>E</b></span>

<p><b>A</b> : Scratch <b>AU</b> : Scratch &amp; Dent <b>B</b> : Modified <b>C</b> : Corrosion <b>G</b> : Stone chip <b>P</b> : Faded <b>S</b> : Rust <b>SC</b> : Rust &amp; Corrosion <b>U</b> : Dent <b>X</b> : Defective <b>Y</b> : Crack, Gap</p>
<p><b>Remarks</b> Rear Seat - Grime - Medium / (L) Front Trim - Grime - Small / (L) Front Seat - Grime - Small / (R) Front Seat - Grime - Small / (R) Front Floor Mat - Missing - Yes / (L) Front Floor Mat - Missing - Yes / Mat Other - Missing - Yes / (R) Front Trim - Grime - Small / Dashboard - Traces of Adhesive Tape - Yes / Ceiling - Grime - Minimal</p>	<p><b>Remarks</b> (R) Front Fender - Repair Traces - Yes / (L) Front Fender - Repair Traces - Yes / (L) Front Fender, Molding - Scratch - Medium / (L) Front Fender, Molding - Modified - Minimal / (L) Step, In-panel, Side Spoiler - Modified - Medium / (L) Front Door, Molding - Scratch &amp; Dent - Small / (L) Rear Door, Molding - Scratch &amp; Dent - Small / Roof - Scratch &amp; Dent - Small / (L) Rear Fender, Molding - Scratch &amp; Dent - Small / Trunk Hood, Rear Gate - Scratch &amp; Dent - Small / (R) Rear Fender, Molding - Scratch &amp; Dent - Small / (R) Rear Door, Molding - Scratch &amp; Dent - Small / (R) Step, In-panel, Side Spoiler - Modified - Medium / (R) Front Door, Molding - Scratch &amp; Dent - Small / (R) Front Fender, Molding - Scratch &amp; Dent - Small / Front Bumper, Grille, Lamps - Scratch - Medium / Front Bumper, Grille, Lamps - Modified - Small / Bonnet, Headlight - Scratch &amp; Dent - Small</p>
