## General Information

<b>Make</b>	Toyota	<b>Model</b>	Avanza
<b>YOM</b>	2025	<b>Odo Meter Reading</b>	4,246
<b>Registration No.</b>	NEK3337	<b>Chassis No.</b>	MHFAA1BY1S0044283
<b>CC</b>	1.3	<b>Transmission</b>	CVT
<b>Fuel Type</b>	Gas	<b>Type of Body</b>	Wagon
<b>Colour</b>	Green

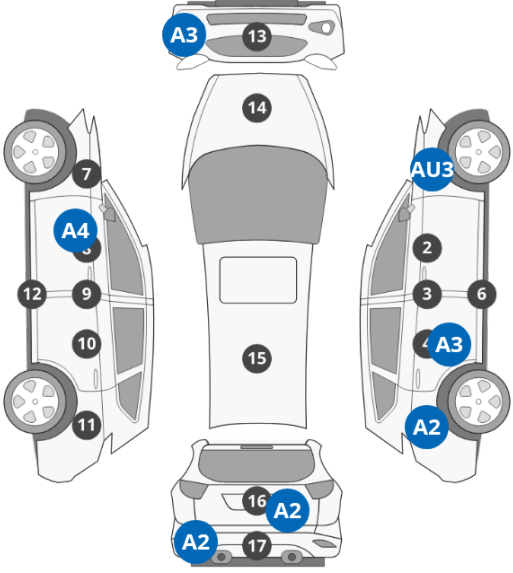
<p><b>A</b> : Scratch <b>AU</b> : Scratch &amp; Dent <b>B</b> : Modified <b>C</b> : Corrosion <b>G</b> : Stone chip <b>P</b> : Faded <b>S</b> : Rust <b>SC</b> : Rust &amp; Corrosion <b>U</b> : Dent <b>X</b> : Defective <b>Y</b> : Crack, Gap</p>
<p><b>Remarks</b> Dashboard - Traces of Adhesive Tape - Yes</p>	<p><b>Remarks</b> (L) Front Door, Molding - Scratch - Large / Front Bumper, Grille, Lamps - Scratch - Medium / (R) Front Fender, Molding - Scratch &amp; Dent - Medium / (R) Rear Door, Molding - Scratch - Medium / (R) Rear Fender, Molding - Scratch - Small / Trunk Hood, Rear Gate - Scratch - Small / Rear Bumper, Lamps, Panels - Scratch - Small</p>
