## General Information

<b>Make</b>	Toyota	<b>Model</b>	Vios
<b>YOM</b>	2021	<b>Odo Meter Reading</b>	55,205
<b>Registration No.</b>	NFI3800	<b>Chassis No.</b>	PA1B18F36M4157220
<b>CC</b>	1.3	<b>Transmission</b>	CVT
<b>Fuel Type</b>	Gas	<b>Type of Body</b>	Sedan
<b>Colour</b>	Blue

## Body / Panel Condition

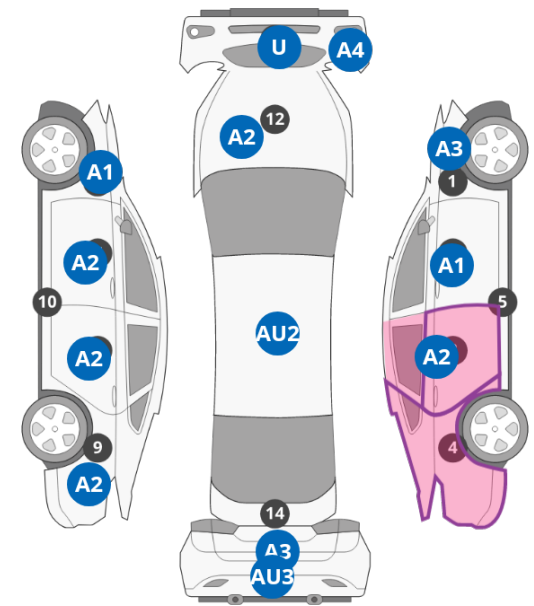
<p><b>A</b> : Scratch <b>AU</b> : Scratch &amp; Dent <b>B</b> : Modified <b>C</b> : Corrosion <b>G</b> : Stone chip <b>P</b> : Faded <b>S</b> : Rust <b>SC</b> : Rust &amp; Corrosion <b>U</b> : Dent <b>X</b> : Defective <b>Y</b> : Crack, Gap</p>
<p><b>Remarks</b> (R) Front Seat - Grime - Large / (R) Front Trim - Grime - Medium / Rear Seat - Grime - Medium / (L) Front Trim - Grime - Medium / (L) Front Seat - Grime - Medium / Ceiling - Grime - Minimal</p>	<p><b>Remarks</b> (R) Rear Fender - Repair Traces - Yes / (R) Rear Door - Repair Traces - Yes / (R) Rear Door, Molding - Repair mark - Yes / (R) Rear Fender, Molding - Repair mark - Yes / (R) Rear Door, Molding - Scratch - Small / (R) Front Door, Molding - Scratch - Minimal / (R) Front Fender, Molding - Scratch - Medium / Front Bumper, Grille, Lamps - Scratch - Large / Bonnet, Headlight - Scratch - Small / (L) Front Fender, Molding - Scratch - Minimal / (L) Front Door, Molding - Scratch - Small / (L) Rear Door, Molding - Scratch - Small / (L) Rear Fender, Molding - Scratch - Small / Trunk Hood, Rear Gate - Scratch - Medium / Rear Bumper, Lamps, Panels - Scratch &amp; Dent - Medium / Roof - Scratch &amp; Dent - Small / Member (Bolted) - Dent - Yes</p>
