## General Information

<b>Make</b>	Toyota	<b>Model</b>	Wigo
<b>YOM</b>	2024	<b>Odo Meter Reading</b>	10,502
<b>Registration No.</b>	NHS2676	<b>Chassis No.</b>	MHKAA1BC8RJ020671
<b>CC</b>	1.0	<b>Transmission</b>	CVT
<b>Fuel Type</b>	Gas	<b>Type of Body</b>	Hatchback
<b>Colour</b>	Gray

## Body / Panel Condition

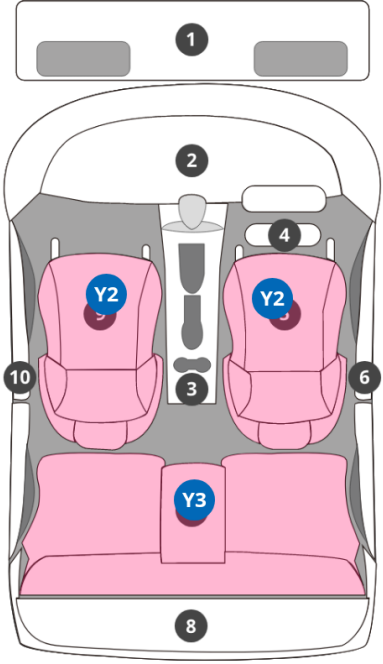
<b>Interior Evaluation :</b> <span style="float: right; color: red; font-weight: bold;">B</span>	<b>Exterior Evaluation :</b> <span style="float: right; color: red; font-weight: bold;">D</span>

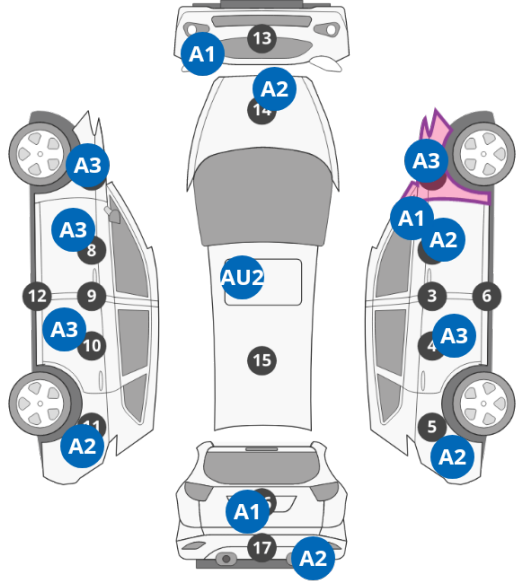
<p><b>A</b> : Scratch <b>AU</b> : Scratch &amp; Dent <b>B</b> : Modified <b>C</b> : Corrosion <b>G</b> : Stone chip <b>P</b> : Faded <b>S</b> : Rust <b>SC</b> : Rust &amp; Corrosion <b>U</b> : Dent <b>X</b> : Defective <b>Y</b> : Crack, Gap</p>
<p><b>Remarks</b> (R) Front Seat - Grime - Small / Rear Seat - Grime - Medium / (L) Front Seat - Grime - Small</p>	<p><b>Remarks</b> (R) Front Fender - Repair Traces - Yes / Roof - Scratch &amp; Dent - Small / (L) Front Fender, Molding - Scratch - Medium / (L) Front Door, Molding - Scratch - Medium / (R) Front Fender, Molding - Repair mark - Yes / (L) Rear Door, Molding - Scratch - Medium / (L) Rear Fender, Molding - Scratch - Small / Rear Bumper, Lamps, Panels - Scratch - Small / Trunk Hood, Rear Gate - Scratch - Minimal / (R) Rear Fender, Molding - Scratch - Small / (R) Rear Door, Molding - Scratch - Medium / (R) Front Door, Molding - Scratch - Small / (R) Mirror - Scratch - Minimal / (R) Front Fender, Molding - Scratch - Medium / Bonnet, Headlight - Scratch - Small / Front Bumper, Grille, Lamps - Scratch - Minimal</p>
