## General Information

Date & Time: 14, Feb, 2026 16:03

<b>Make</b>	Toyota	<b>Model</b>	Hilux Tamaraw
<b>YOM</b>	2025	<b>Odo Meter Reading</b>	35,138
<b>Registration No.</b>	CCG7962	<b>Chassis No.</b>	PAHACACA8R542038
<b>CC</b>	2.4	<b>Transmission</b>	M/T
<b>Fuel Type</b>	Diesel	<b>Type of Body</b>	Utility Vehicle
<b>Colour</b>	White

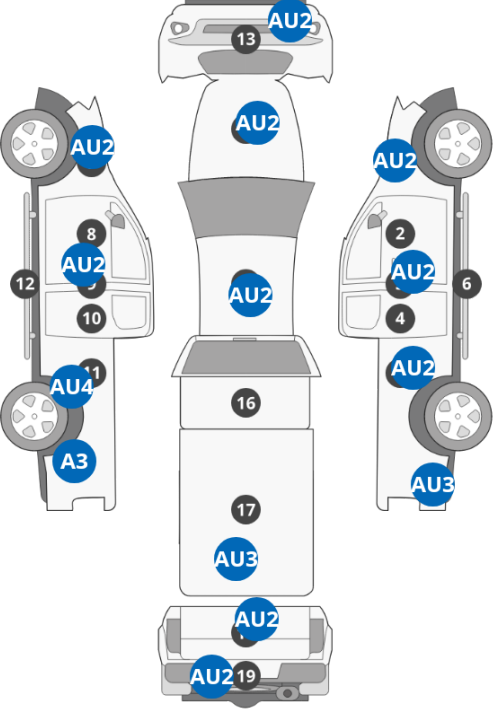
<p><b>A</b> : Scratch <b>AU</b> : Scratch &amp; Dent <b>B</b> : Modified <b>C</b> : Corrosion <b>G</b> : Stone chip <b>P</b> : Faded <b>S</b> : Rust <b>SC</b> : Rust &amp; Corrosion <b>U</b> : Dent <b>X</b> : Defective <b>Y</b> : Crack, Gap</p>
<p><b>Remarks</b> (L) Front Floor Mat - Grime - Medium / (R) Front Floor Mat - Grime - Small / (L) Front Seat - Grime - Small / (R) Front Seat - Grime - Small / Rear Seat - Grime - Small / (L) Front Trim - Grime - Minimal / (R) Front Trim - Grime - Minimal / Ceiling - Grime - Small</p>	<p><b>Remarks</b> Roof - Repair Traces - Yes / Rear Bumper, Lamps, Panels - Scratch &amp; Dent - Small / (L) Side Gate - Scratch - Medium / (L) Guard Frame - Scratch &amp; Dent - Large / (L) Front Door, Molding - Scratch &amp; Dent - Small / (L) Front Fender, Molding - Scratch &amp; Dent - Small / Bonnet, Headlight - Scratch &amp; Dent - Small / Front Bumper, Grille, Lamps - Scratch &amp; Dent - Small / (R) Front Fender, Molding - Scratch &amp; Dent - Small / Roof - Scratch &amp; Dent - Small / (R) Front Door, Molding - Scratch &amp; Dent - Small / (R) Guard Frame - Scratch &amp; Dent - Small / (R) Side Gate - Scratch &amp; Dent - Medium / Rear Gate - Scratch &amp; Dent - Small / Cargo Bed Floor - Scratch &amp; Dent - Medium</p>
