## General Information

<b>Make</b>	Toyota	<b>Model</b>	Vios
<b>YOM</b>	2024	<b>Odo Meter Reading</b>	38,178
<b>Registration No.</b>	NFS3907	<b>Chassis No.</b>	PA1B18F34P2436230
<b>CC</b>	1.3	<b>Transmission</b>	CVT
<b>Fuel Type</b>	Gas	<b>Type of Body</b>	Sedan
<b>Colour</b>	Black

## Body / Panel Condition

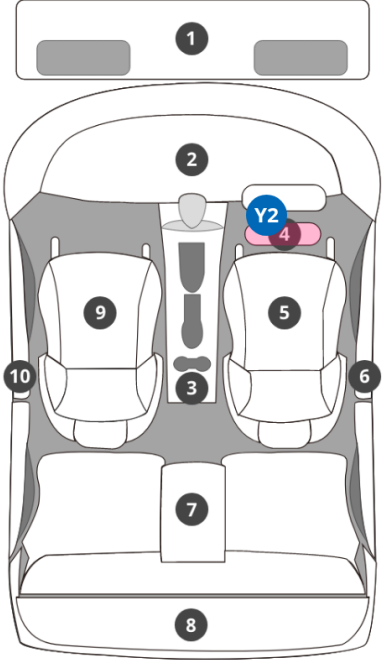
<b>Interior Evaluation :</b> <span style="color: red; font-weight: bold; font-size: 1.2em;">A</span>	<b>Exterior Evaluation :</b> <span style="color: red; font-weight: bold; font-size: 1.2em;">E</span>

<p><b>A</b> : Scratch <b>AU</b> : Scratch &amp; Dent <b>B</b> : Modified <b>C</b> : Corrosion <b>G</b> : Stone chip <b>P</b> : Faded <b>S</b> : Rust <b>SC</b> : Rust &amp; Corrosion <b>U</b> : Dent <b>X</b> : Defective <b>Y</b> : Crack, Gap</p>
<b>Remarks</b> (L) Front Floor Mat - Grime - Small	<b>Remarks</b> (R) Front Fender, Molding - Scratch & Dent - Medium / (R) Front Door, Molding - Scratch & Dent - Medium / (R) Mirror - Scratch - Minimal / (R) Step, In-panel, Side Spoiler - Scratch - Minimal / (R) Rear Door, Molding - Scratch & Dent - Large / (R) Rear Fender, Molding - Scratch - Minimal / Rear Bumper, Lamps, Panels - Repair mark - Yes - Small / (L) Rear Fender, Molding - Scratch & Dent - Medium / (L) Rear Door, Molding - Scratch & Dent - Large / (L) Step, In-panel, Side Spoiler - Scratch - Minimal / (L) Front Door, Molding - Scratch - Small / (L) Mirror - Scratch - Minimal / (L) Front Fender, Molding - Scratch & Dent - Large / Roof - Scratch - Small / Front Bumper, Grille, Lamps - Scratch - Large / Bonnet, Headlight - Scratch & Dent - Large

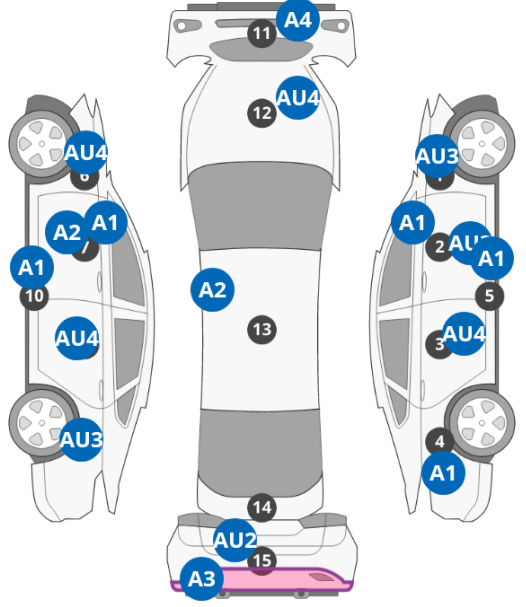
<b>Inspector Notes</b>
With Lto plate, with warranty booklet, with spare tire, with jack and tools, scratches on headlights and taillights
