General Information

Date & Time: 13, Feb, 2026 12:04

| Make | Toyota | Model | Vios |
| Registration No. | NKI3769 | Chassis No. | PA1B18F32R4260142 |

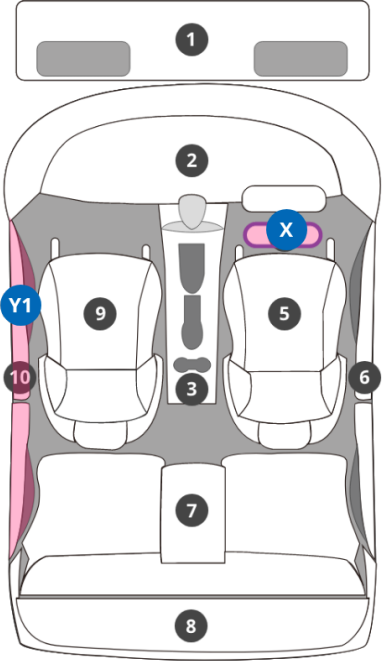
| Interior Evaluation : B | Exterior Evaluation : D |
| <p>Remarks (L) Front Floor Mat - Missing - Yes / (L) Front Trim - Grime - Minimal</p> | <p>Remarks (R) Front Door - Repair Traces - Yes / (R) Front Fender - Repair Traces - Yes / Bonnet - Repair Traces - Yes / (L) Front Fender - Repair Traces - Yes / (L) Front Door - Repair Traces - Yes / (L) Rear Door - Repair Traces - Yes / (L) Rear Fender - Repair Traces - Yes / Trunk Hood, Rear Gate - Repair Traces - Yes / (R) Rear Fender - Repair Traces - Yes / (R) Rear Door - Repair Traces - Yes / Roof - Repair Traces - Yes / Overall Exterior - Full Re-Paint in same color - Yes / (R) Front Fender, Molding - Repair mark - Yes / (R) Front Door, Molding - Repair mark - Yes / (R) Front Fender, Molding - Scratch - Minimal / (R) Mirror - Scratch - Small / (R) Front Door, Molding - Scratch - Small / (R) Step, In-panel, Side Spoiler - Scratch - Minimal / (R) Rear Door, Molding - Scratch - Small / (R) Rear Fender, Molding - Repair mark - Yes / (R) Rear Door, Molding - Repair mark - Yes / (R) Rear Fender, Molding - Scratch - Small / Rear Bumper, Lamps, Panels - Crack, Gap - Medium / Trunk Hood, Rear Gate - Scratch - Minimal / (L) Rear Fender, Molding - Scratch - Minimal / (L) Rear Door, Molding - Scratch - Medium / (L) Front Door, Molding - Scratch - Small / (L) Front Fender, Molding - Scratch - Minimal / (L) Step, In-panel, Side Spoiler - Scratch - Minimal / Bonnet, Headlight - Scratch & Dent - Small / Front Bumper, Grille, Lamps - Scratch & Dent - Medium</p> |
