## General Information

<b>Make</b>	Toyota	<b>Model</b>	Vios
<b>YOM</b>	2025	<b>Odo Meter Reading</b>	33,162
<b>Registration No.</b>	NKG2509	<b>Chassis No.</b>	PA1B18F39R4275379
<b>CC</b>	1.3	<b>Transmission</b>	CVT
<b>Fuel Type</b>	Gas	<b>Type of Body</b>	Sedan
<b>Colour</b>	Blue

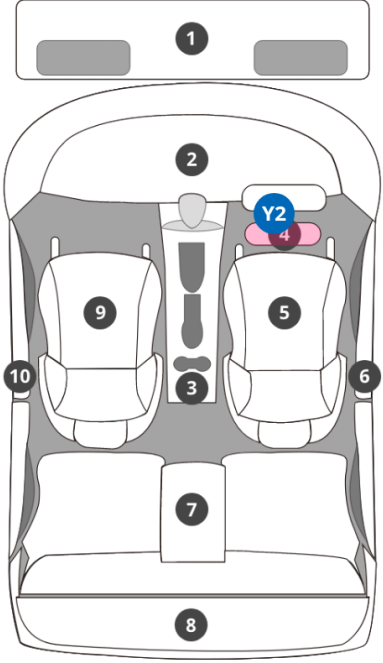
<b>Interior Evaluation :</b> <span style="float: right; color: red; font-weight: bold;">A</span>	<b>Exterior Evaluation :</b> <span style="float: right; color: red; font-weight: bold;">D</span>

<p><b>a</b> : Cut, Fray <b>d</b> : Loose, Deformed <b>k</b> : Animal Hair <b>s</b> : Smell <b>t</b> : Cigarette Burns <b>x</b> : Defective <b>y</b> : Stain</p>

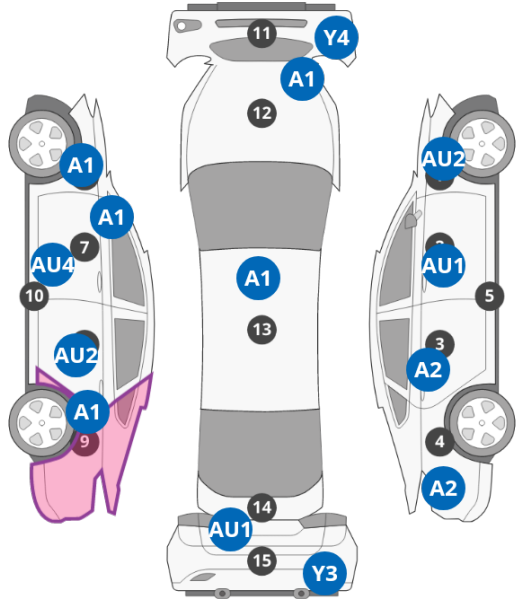
<p><b>A</b> : Scratch <b>AU</b> : Scratch &amp; Dent <b>B</b> : Modified <b>C</b> : Corrosion <b>G</b> : Stone chip <b>P</b> : Faded <b>S</b> : Rust <b>SC</b> : Rust &amp; Corrosion <b>U</b> : Dent <b>X</b> : Defective <b>Y</b> : Crack, Gap</p>
<b>Remarks</b> (L) Front Floor Mat - Grime - Small	<b>Remarks</b> (L) Rear Fender - Repair Traces - Yes / Trunk Hood, Rear Gate - Repair Traces - Yes / (R) Front Fender, Molding - Scratch & Dent - Small / (R) Front Door, Molding - Scratch & Dent - Minimal / (R) Rear Door, Molding - Scratch - Small / (R) Rear Fender, Molding - Scratch - Small / Trunk Hood, Rear Gate - Scratch & Dent - Minimal / Rear Bumper, Lamps, Panels - Crack, Gap - Medium / (L) Rear Fender, Molding - Repair mark - Yes / (L) Rear Fender, Molding - Scratch - Minimal / (L) Rear Door, Molding - Scratch & Dent - Small / (L) Mirror - Scratch - Minimal / (L) Front Door, Molding - Scratch & Dent - Large / Roof - Scratch - Minimal / (L) Front Fender, Molding - Scratch - Minimal / Front Bumper, Grille, Lamps - Crack, Gap - Large / Bonnet, Headlight - Scratch - Minimal

With Lto plate, with jack, 1key, no warranty booklet, no spare tire and tools, Crack headlight and taillight, battery weak
