## General Information

<b>Make</b>	Toyota	<b>Model</b>	Vios
<b>YOM</b>	2025	<b>Odo Meter Reading</b>	30,032
<b>Registration No.</b>	DBR3696	<b>Chassis No.</b>	PA1B18F34R4273341
<b>CC</b>	1.3	<b>Transmission</b>	CVT
<b>Fuel Type</b>	Gas	<b>Type of Body</b>	Sedan
<b>Colour</b>	Red

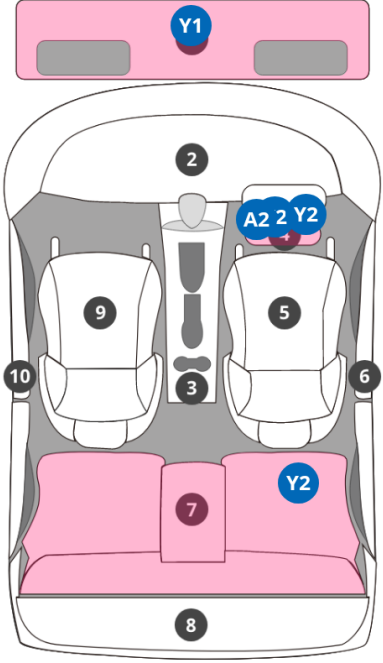
<b>Interior Evaluation :</b> <span style="float: right;"><b>B</b></span>	<b>Exterior Evaluation :</b> <span style="float: right;"><b>C</b></span>

<p><b>a</b> : Cut, Fray <b>d</b> : Loose, Deformed <b>k</b> : Animal Hair <b>s</b> : Smell <b>t</b> : Cigarette Burns <b>x</b> : Defective <b>y</b> : Stain</p>

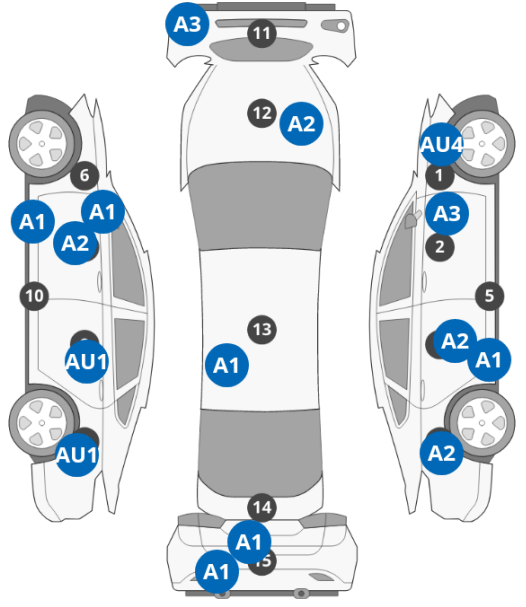
<p><b>A</b> : Scratch <b>AU</b> : Scratch &amp; Dent <b>B</b> : Modified <b>C</b> : Corrosion <b>G</b> : Stone chip <b>P</b> : Faded <b>S</b> : Rust <b>SC</b> : Rust &amp; Corrosion <b>U</b> : Dent <b>X</b> : Defective <b>Y</b> : Crack, Gap</p>
<p><b>Remarks</b> (L) Front Floor Mat - Grime - Small / Ceiling - Grime - Minimal / Rear Seat - Grime - Small / Mat Other - Grime - Small / (R) Front Floor Mat - Cut, Crack - Small</p>	<p><b>Remarks</b> (R) Front Fender, Molding - Scratch &amp; Dent - Large / (R) Front Door, Molding - Scratch - Medium / (R) Rear Door, Molding - Scratch - Small / (R) Rear Fender, Molding - Scratch - Small / (R) Step, In-panel, Side Spoiler - Scratch - Minimal / Rear Bumper, Lamps, Panels - Scratch - Minimal / Trunk Hood, Rear Gate - Scratch - Minimal / (L) Rear Fender, Molding - Scratch &amp; Dent - Minimal / (L) Rear Door, Molding - Scratch &amp; Dent - Minimal / Roof - Scratch - Minimal / (L) Step, In-panel, Side Spoiler - Scratch - Minimal / (L) Front Door, Molding - Scratch - Small / Front Bumper, Grille, Lamps - Scratch - Medium / Bonnet, Headlight - Scratch - Small / (L) Mirror - Scratch - Minimal</p>
