## General Information

<b>Make</b>	Toyota	<b>Model</b>	Wigo
<b>YOM</b>	2021	<b>Odo Meter Reading</b>	22,798
<b>Registration No.</b>	DBF1681	<b>Chassis No.</b>	MHKA4DF5FMJ057937
<b>CC</b>	1.0	<b>Transmission</b>	A/T
<b>Fuel Type</b>	Gas	<b>Type of Body</b>	Hatchback
<b>Colour</b>	Black

## Body / Panel Condition

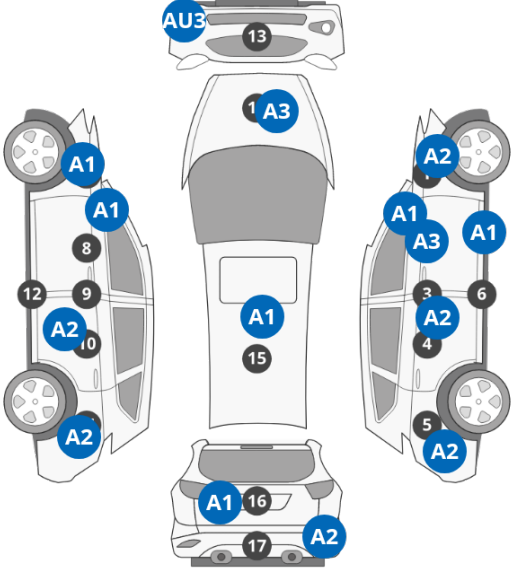
<p><b>A</b> : Scratch <b>AU</b> : Scratch &amp; Dent <b>B</b> : Modified <b>C</b> : Corrosion <b>G</b> : Stone chip <b>P</b> : Faded <b>S</b> : Rust <b>SC</b> : Rust &amp; Corrosion <b>U</b> : Dent <b>X</b> : Defective <b>Y</b> : Crack, Gap</p>
<p><b>Remarks</b> Dashboard - Traces of Adhesive Tape - Yes</p>	<p><b>Remarks</b> (R) Front Fender, Molding - Scratch - Small / (R) Mirror - Scratch - Minimal / (R) Step, In-panel, Side Spoiler - Scratch - Minimal / (R) Front Door, Molding - Scratch - Medium / (R) Rear Door, Molding - Scratch - Small / (R) Rear Fender, Molding - Scratch - Small / Rear Bumper, Lamps, Panels - Scratch - Small / Trunk Hood, Rear Gate - Scratch - Minimal / (L) Rear Fender, Molding - Scratch - Small / (L) Rear Door, Molding - Scratch - Small / (L) Mirror - Scratch - Minimal / (L) Front Fender, Molding - Scratch - Minimal / Front Bumper, Grille, Lamps - Scratch &amp; Dent - Medium / Roof - Scratch - Minimal / Bonnet, Headlight - Scratch - Medium</p>

<p><b>Inspector Notes</b></p>
<p>With Lto plate, with warranty booklet, with spare tire, 1key, no jack and tools, scratches on headlights and taillights</p>
