General Information

Date & Time: 13, Feb, 2026 09:03

Make	Nissan	Model	NV350
YOM	2020	Odo Meter Reading	93,392
Registration No.	NFW7862	Chassis No.	JNT1TC2E26Z0059870
CC	2.5	Transmission	M/T
Fuel Type	Diesel	Type of Body	Van
Colour	White

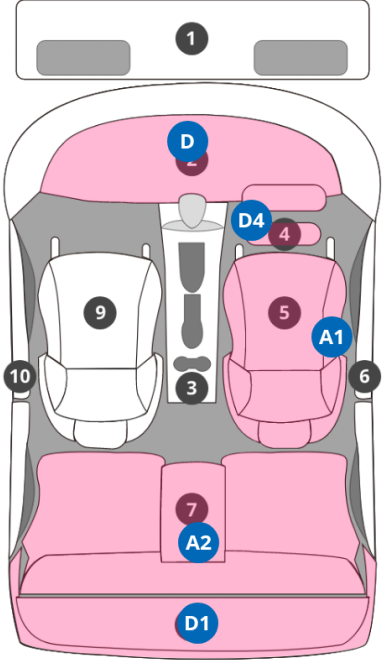
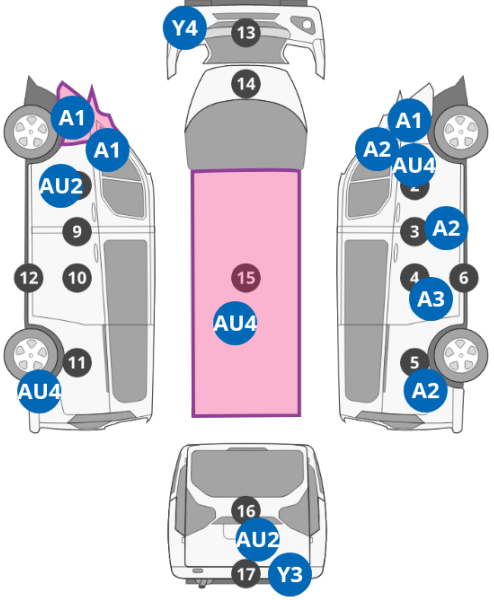
Interior Evaluation :	C	Exterior Evaluation :	E

<p>a : Cut, Fray d : Loose, Deformed k : Animal Hair s : Smell t : Cigarette Burns x : Defective y : Stain</p>		<p>A : Scratch AU : Scratch & Dent B : Modified C : Corrosion G : Stone chip P : Faded S : Rust SC : Rust & Corrosion U : Dent X : Defective Y : Crack, Gap</p>	
<p>Remarks Dashboard - Traces of Adhesive Tape - Yes / (R) Front Seat - Cut, Crack - Minimal / Rear Seat - Cut, Crack - Small / Trunk Room - Worked - Minimal / Overall Interior - Worn as per age - Yes / Carpet - Worked - Large</p>		<p>Remarks Front Panel - Repair Traces - Yes / Trunk Hood, Rear Gate - Repair Traces - Yes / (R) Rear Fender - Repair Traces - Yes / (R) Rear Door - Repair Traces - Yes / (R) Center Panel - Repair Traces - Yes / Roof - Repair Traces - Yes / (R) Front Fender, Molding - Scratch - Minimal / (R) Mirror - Scratch - Small / (R) Front Door, Molding - Scratch & Dent - Large / (R) Center Panel - Scratch - Small / (R) Rear Door, Molding - Scratch - Medium / Roof - Scratch & Dent - Large / (R) Rear Fender, Molding - Scratch - Small / Rear Bumper, Lamps, Panels - Crack, Gap - Medium / Trunk Hood, Rear Gate - Scratch & Dent - Small / (L) Rear Fender, Molding - Scratch & Dent - Large / (L) Mirror - Scratch - Minimal / (L) Front Door, Molding - Scratch & Dent - Small / Overall Exterior - Full Re-Paint in same color - Yes / Front Bumper, Grille, Lamps - Crack, Gap - Large / (L) Front Fender, Molding - Repair mark - Yes / (L) Front Fender, Molding - Scratch - Minimal / Roof - Repair mark - Yes</p>
