## General Information

<b>Make</b>	Mitsubishi	<b>Model</b>	Mirage
<b>YOM</b>	2021	<b>Odo Meter Reading</b>	78,946
<b>Registration No.</b>	NET2907	<b>Chassis No.</b>	PAEA13RJMMMA020679
<b>CC</b>	1.2	<b>Transmission</b>	A/T
<b>Fuel Type</b>	Gas	<b>Type of Body</b>	Sedan
<b>Colour</b>	Silver

## Body / Panel Condition

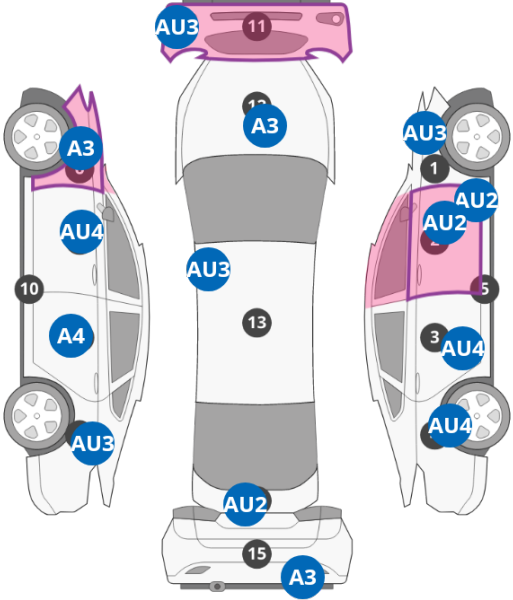
<p><b>A</b> : Scratch <b>AU</b> : Scratch &amp; Dent <b>B</b> : Modified <b>C</b> : Corrosion <b>G</b> : Stone chip <b>P</b> : Faded <b>S</b> : Rust <b>SC</b> : Rust &amp; Corrosion <b>U</b> : Dent <b>X</b> : Defective <b>Y</b> : Crack, Gap</p>
<p><b>Remarks</b> (L) Front Floor Mat - Grime - Medium / (R) Front Floor Mat - Grime - Small / (L) Front Seat - Cut, Crack - Medium / (R) Front Seat - Worn - Yes / Mat Other - Grime - Small / Rear Seat - Grime - Small / (L) Front Trim - Grime - Small / (R) Front Trim - Grime - Small / Ceiling - Grime - Medium</p>	<p><b>Remarks</b> (R) Front Fender - Repair Traces - Yes / (L) Front Fender - Repair Traces - Yes / Roof - Scratch &amp; Dent - Medium / (L) Rear Door, Molding - Scratch - Large / (L) Front Door, Molding - Scratch &amp; Dent - Large / (L) Front Fender, Molding - Repair mark - Yes / (L) Front Fender, Molding - Scratch - Medium / Front Bumper, Grille, Lamps - Scratch &amp; Dent - Medium / Front Bumper, Grille, Lamps - Repair mark - Yes / Bonnet, Headlight - Scratch - Medium / (R) Front Fender, Molding - Scratch &amp; Dent - Medium / (R) Step, In-panel, Side Spoiler - Scratch &amp; Dent - Small / (R) Front Door, Molding - Scratch &amp; Dent - Small / (R) Front Door, Molding - Repair mark - Yes / (R) Rear Door, Molding - Scratch &amp; Dent - Large / (R) Rear Fender, Molding - Scratch &amp; Dent - Large / Rear Bumper, Lamps, Panels - Scratch - Medium / Trunk Hood, Rear Gate - Scratch &amp; Dent - Small / (L) Rear Fender, Molding - Scratch &amp; Dent - Medium</p>
