General Information

Date & Time: 17, Feb, 2026 08:10

Make	Suzuki	Model	Ertiga
YOM	2020	Odo Meter Reading	40,559
Registration No.	NEK1401	Chassis No.	MHYNC22S3LJ112891
CC	1.5	Transmission	A/T
Fuel Type	Gas	Type of Body	Utility Vehicle
Colour	Red

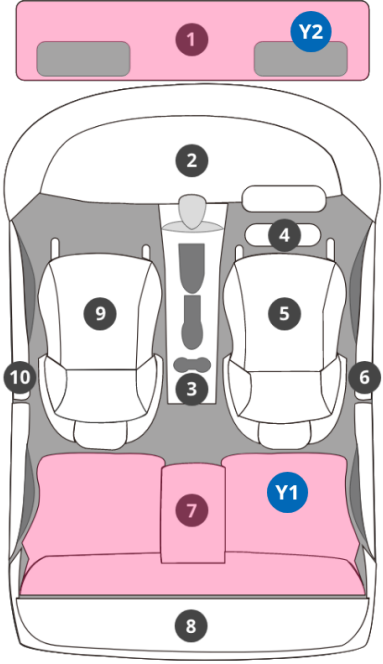
Interior Evaluation : A	Exterior Evaluation : D

<p>a : Cut, Fray d : Loose, Deformed k : Animal Hair s : Smell t : Cigarette Burns x : Defective y : Stain</p>

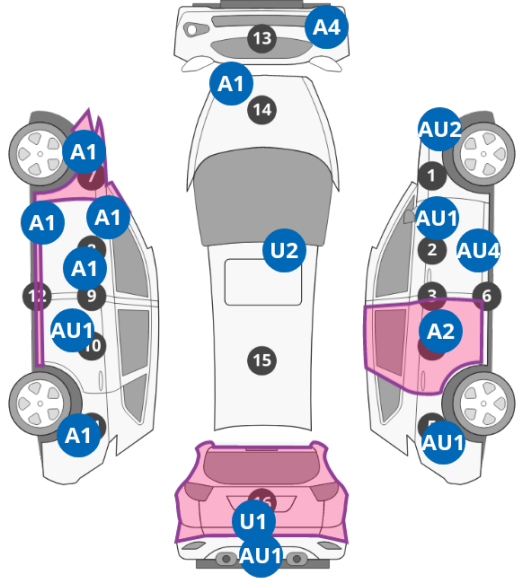
<p>A : Scratch AU : Scratch & Dent B : Modified C : Corrosion G : Stone chip P : Faded S : Rust SC : Rust & Corrosion U : Dent X : Defective Y : Crack, Gap</p>
Remarks Ceiling - Grime - Small / Rear Seat - Grime - Minimal	Remarks (R) Front Door - Repair Traces - Yes / (R) Front Fender - Repair Traces - Yes / Bonnet - Repair Traces - Yes / (L) Front Fender - Repair Traces - Yes / (L) Front Door - Repair Traces - Yes / (L) Rear Door - Repair Traces - Yes / (L) Rear Fender - Repair Traces - Yes / Trunk Hood, Rear Gate - Repair Traces - Yes / (R) Rear Fender - Repair Traces - Yes / (R) Rear Door - Repair Traces - Yes / Roof - Repair Traces - Yes / (R) Front Fender, Molding - Scratch & Dent - Small / Overall Exterior - Full Re-Paint in same color - Yes / (R) Front Door, Molding - Scratch & Dent - Minimal / (R) Step, In-panel, Side Spoiler - Scratch & Dent - Large / (R) Rear Door, Molding - Repair mark - Yes / (R) Rear Door, Molding - Scratch - Small / (R) Rear Fender, Molding - Scratch & Dent - Minimal / Trunk Hood, Rear Gate - Repair mark - Yes / Rear Bumper, Lamps, Panels - Scratch & Dent - Minimal / Trunk Hood, Rear Gate - Dent - Minimal / (L) Rear Fender, Molding - Scratch - Minimal / (L) Rear Door, Molding - Scratch & Dent - Minimal / (L) Front Door, Molding - Scratch - Minimal / (L) Mirror - Scratch - Minimal / (L) Step, In-panel, Side Spoiler - Repair mark - Yes / (L) Step, In-panel, Side Spoiler - Scratch - Minimal / (L) Front Fender, Molding - Repair mark - Yes / (L) Front Fender, Molding - Scratch - Minimal / Front Bumper, Grille, Lamps - Scratch - Large / Bonnet, Headlight - Scratch - Minimal / Roof - Dent - Small
