## General Information

<b>Make</b>	Toyota	<b>Model</b>	Fortuner
<b>YOM</b>	2019	<b>Odo Meter Reading</b>	112,585
<b>Registration No.</b>	NDP5606	<b>Chassis No.</b>	MHFJB8GS9K1568947
<b>CC</b>	2.4	<b>Transmission</b>	A/T
<b>Fuel Type</b>	Diesel	<b>Type of Body</b>	SUV
<b>Colour</b>	Black

## Body / Panel Condition

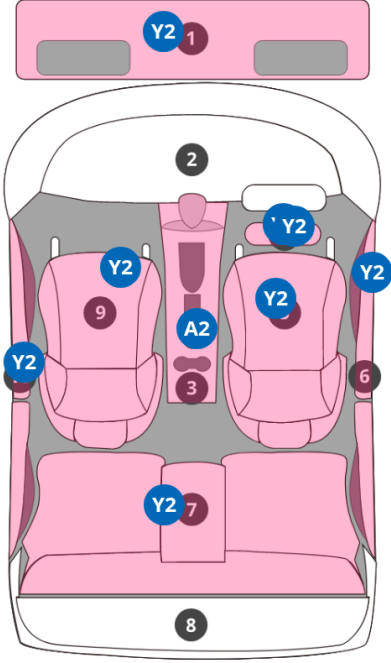
<b>Interior Evaluation :</b> <span style="float: right; color: red; font-weight: bold;">C</span>	<b>Exterior Evaluation :</b> <span style="float: right; color: red; font-weight: bold;">E</span>

<p><b>a</b> : Cut, Fray <b>d</b> : Loose, Deformed <b>k</b> : Animal Hair <b>s</b> : Smell <b>t</b> : Cigarette Burns <b>x</b> : Defective <b>y</b> : Stain</p>

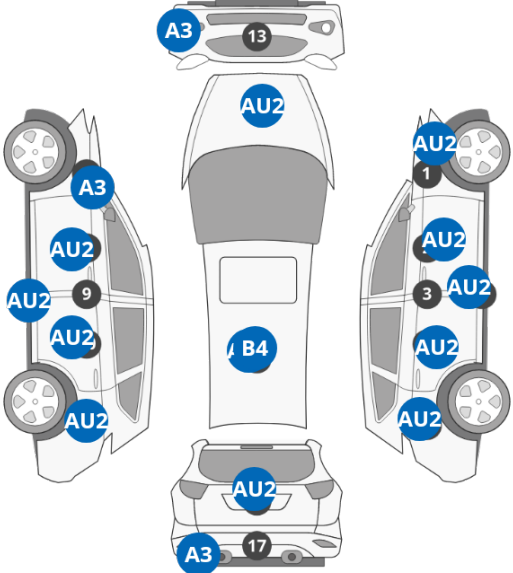
<p><b>A</b> : Scratch <b>AU</b> : Scratch &amp; Dent <b>B</b> : Modified <b>C</b> : Corrosion <b>G</b> : Stone chip <b>P</b> : Faded <b>S</b> : Rust <b>SC</b> : Rust &amp; Corrosion <b>U</b> : Dent <b>X</b> : Defective <b>Y</b> : Crack, Gap</p>
<p><b>Remarks</b> (L) Front Floor Mat - Grime - Medium / (R) Front Floor Mat - Grime - Small / Knobs - Worn, Peel, Crack - Small / Ceiling - Grime - Small / (R) Front Seat - Grime - Small / (L) Front Seat - Grime - Small / Rear Seat - Grime - Small / (L) Rear Trim - Grime - Small / (R) Front Trim - Grime - Small / Mat Other - Grime - Small</p>	<p><b>Remarks</b> (R) Front Fender - Repair Traces - Yes / Bonnet - Repair Traces - Yes / (L) Front Fender - Repair Traces - Yes / (L) Rear Fender - Repair Traces - Yes / (L) Front Fender, Molding - Scratch - Medium / Bonnet, Headlight - Scratch &amp; Dent - Small / Front Bumper, Grille, Lamps - Scratch - Medium / (R) Front Door, Molding - Scratch &amp; Dent - Small / (R) Front Fender, Molding - Scratch &amp; Dent - Small / (R) Rear Door, Molding - Scratch &amp; Dent - Small / (R) Rear Fender, Molding - Scratch &amp; Dent - Small / Trunk Hood, Rear Gate - Scratch &amp; Dent - Small / Rear Bumper, Lamps, Panels - Scratch - Medium / (L) Rear Fender, Molding - Scratch &amp; Dent - Small / (L) Rear Door, Molding - Scratch &amp; Dent - Small / (L) Front Door, Molding - Scratch &amp; Dent - Small / (L) Step, In-panel, Side Spoiler - Scratch &amp; Dent - Small / (R) Step, In-panel, Side Spoiler - Scratch &amp; Dent - Small / Roof - Scratch &amp; Dent - Small / Roof Spoiler, Molding - Modified - Large</p>
