## General Information

| Make | Toyota | Model | Wigo |
| Registration No. | EAJ3277 | Chassis No. | MHKAA1BC5PJ003307 |

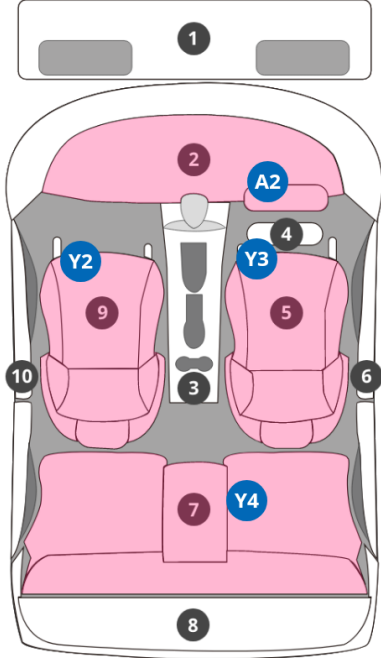
| Interior Evaluation : <span style="color: red; font-weight: bold;">C</span> | Exterior Evaluation : <span style="color: red; font-weight: bold;">C</span> |
| <p><b>Remarks</b></p> <p>Rear Seat - Grime - Large / (L) Front Seat - Grime - Small / (R) Front Seat - Grime - Medium / Steering Wheel - Worn, Peel, Crack - Small</p> | <p><b>Remarks</b></p> <p>Front Bumper, Grille, Lamps - Scratch - Large / (R) Front Door, Molding - Scratch &amp; Dent - Medium / (L) Front Fender, Molding - Scratch - Medium / Roof - Scratch - Small / Rear Bumper, Lamps, Panels - Scratch - Minimal</p> |
