General Information

| Make | Toyota | Model | Wigo |
| Registration No. | CBU1943 | Chassis No. | MHKA4DF5FPJ079699 |

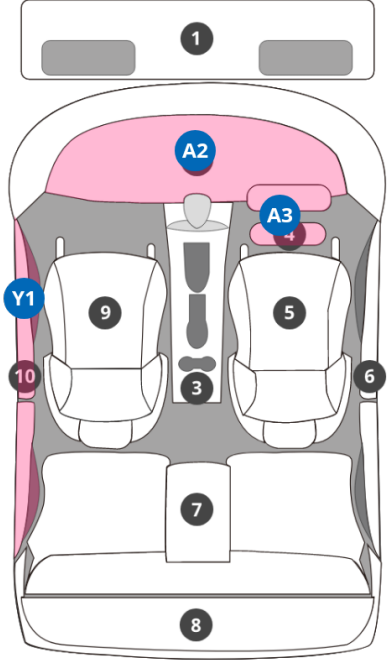
| Interior Evaluation : B | Exterior Evaluation : D |
| <p>Remarks Dashboard - Worn, Scratch, Cut, Crack - Small / (L) Front Trim - Grime - Minimal / (L) Front Floor Mat - Cut, Crack - Medium</p> | <p>Remarks (R) Step - Repair Traces - Yes / (R) Front Fender, Molding - Scratch - Minimal / (R) Mirror - Scratch - Minimal / (R) Front Door, Molding - Scratch & Dent - Minimal / (R) Rear Door, Molding - Scratch - Medium / (R) Step, In-panel, Side Spoiler - Repair mark - Yes / (R) Step, In-panel, Side Spoiler - Scratch - Minimal / (R) Rear Fender, Molding - Scratch & Dent - Minimal / Rear Bumper, Lamps, Panels - Crack, Gap - Medium / Trunk Hood, Rear Gate - Scratch - Minimal / (L) Rear Fender, Molding - Scratch & Dent - Small / (L) Step, In-panel, Side Spoiler - Scratch & Dent - Small / (L) Rear Door, Molding - Scratch - Small / (L) Mirror - Scratch - Minimal / (L) Front Door, Molding - Scratch - Small / (L) Front Fender, Molding - Scratch - Minimal / Bonnet, Headlight - Scratch - Small / Front Bumper, Grille, Lamps - Scratch & Dent - Large / Bonnet, Headlight - Repair mark - Yes</p> |
