## General Information

Date & Time: 13, Feb, 2026 18:04

<b>Make</b>	Nissan	<b>Model</b>	Navara
<b>YOM</b>	2019	<b>Odo Meter Reading</b>	65,382
<b>Registration No.</b>	NDN6538	<b>Chassis No.</b>	MNTCC2D23Z0068949
<b>CC</b>	2.5	<b>Transmission</b>	M/T
<b>Fuel Type</b>	Diesel	<b>Type of Body</b>	Pickup
<b>Colour</b>	White

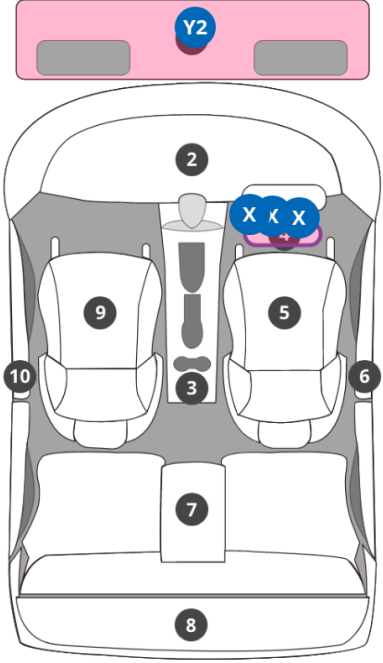
<b>Interior Evaluation :</b> <span style="float: right;"><b>B</b></span>	<b>Exterior Evaluation :</b> <span style="float: right;"><b>C</b></span>

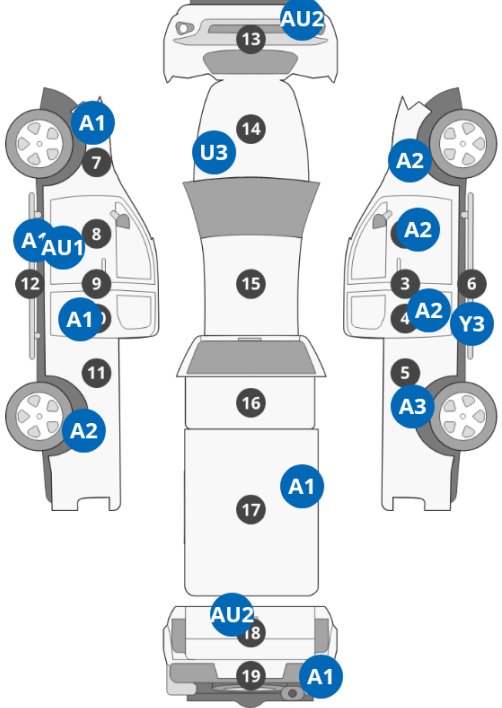
<p><b>A</b> : Scratch <b>AU</b> : Scratch &amp; Dent <b>B</b> : Modified <b>C</b> : Corrosion <b>G</b> : Stone chip <b>P</b> : Faded <b>S</b> : Rust <b>SC</b> : Rust &amp; Corrosion <b>U</b> : Dent <b>X</b> : Defective <b>Y</b> : Crack, Gap</p>
<p><b>Remarks</b> Mat Other - Missing - Yes / (R) Front Floor Mat - Missing - Yes / (L) Front Floor Mat - Missing - Yes / Ceiling - Grime - Small</p>	<p><b>Remarks</b> (R) Front Door - Repair Traces - Yes / (R) Front Fender - Repair Traces - Yes / Bonnet - Repair Traces - Yes / (L) Front Door - Repair Traces - Yes / (L) Rear Door - Repair Traces - Yes / (L) Rear Corner Panel - Repair Traces - Yes / Roof - Repair Traces - Yes / (R) Front Fender, Molding - Scratch - Small / (R) Front Door, Molding - Scratch - Small / (R) Step, In-panel, Side Spoiler - Crack, Gap - Medium / (R) Rear Door, Molding - Scratch - Small / (R) Side Gate - Scratch - Medium / Rear Gate - Scratch &amp; Dent - Small / Rear Bumper, Lamps, Panels - Scratch - Minimal / (L) Side Gate - Scratch - Small / (L) Step, In-panel, Side Spoiler - Scratch - Minimal / (L) Rear Door, Molding - Scratch - Minimal / Roof - Scratch - Minimal / (L) Front Door, Molding - Scratch &amp; Dent - Minimal / (L) Front Fender, Molding - Scratch - Minimal / Bonnet, Headlight - Dent - Medium / Front Bumper, Grille, Lamps - Scratch &amp; Dent - Small</p>
