General Information

Date & Time: 13, Feb, 2026 18:08

Make	Toyota	Model	Vios
YOM	2021	Odo Meter Reading	40,476
Registration No.	NFC1522	Chassis No.	PA1B18F37M4143794
CC	1.3	Transmission	CVT
Fuel Type	Gas	Type of Body	Sedan
Colour	Blue

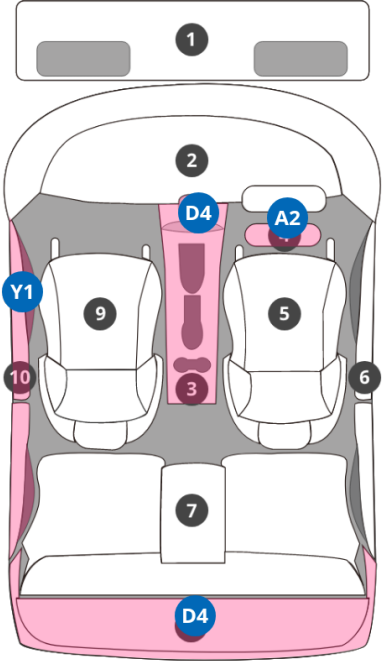
Interior Evaluation : C	Exterior Evaluation : C

<p>a : Cut, Fray d : Loose, Deformed k : Animal Hair s : Smell t : Cigarette Burns x : Defective y : Stain</p>

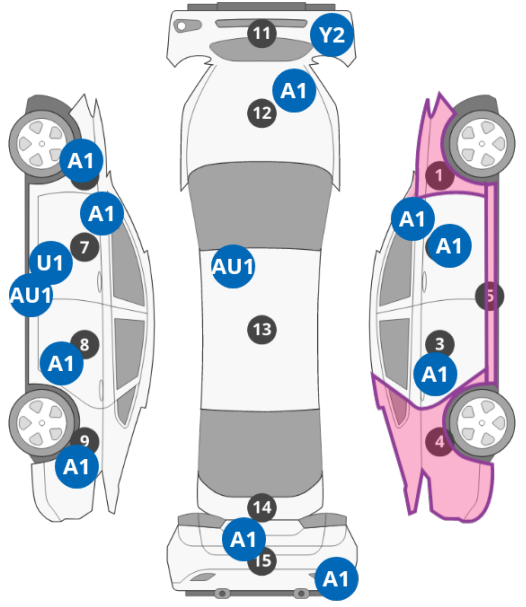
<p>A : Scratch AU : Scratch & Dent B : Modified C : Corrosion G : Stone chip P : Faded S : Rust SC : Rust & Corrosion U : Dent X : Defective Y : Crack, Gap</p>
<p>Remarks Trunk Room - Loose, Deformed - Large / (L) Front Floor Mat - Cut, Crack - Small / (L) Front Trim - Grime - Minimal / Console, Switches, Vents - Loose, Deformed - Large</p>	<p>Remarks (R) Front Door - Repair Traces - Yes / (R) Step - Repair Traces - Yes / (R) Front Fender - Repair Traces - Yes / Bonnet - Repair Traces - Yes / (L) Front Fender - Repair Traces - Yes / (L) Front Door - Repair Traces - Yes / (L) Step - Repair Traces - Yes / (L) Rear Door - Repair Traces - Yes / (L) Rear Fender - Repair Traces - Yes / Trunk Hood, Rear Gate - Repair Traces - Yes / (R) Rear Fender - Repair Traces - Yes / (R) Rear Door - Repair Traces - Yes / Roof - Repair Traces - Yes / Overall Exterior - Full Re-Paint in same color - Yes / (R) Front Fender, Molding - Repair mark - Difference in Color / (R) Mirror - Scratch - Minimal / (R) Front Door, Molding - Scratch - Minimal / (R) Step, In-panel, Side Spoiler - Repair mark - Yes / (R) Rear Door, Molding - Scratch - Minimal / (R) Rear Fender, Molding - Repair mark - Yes / Trunk Hood, Rear Gate - Scratch - Minimal / Rear Bumper, Lamps, Panels - Scratch - Minimal / (L) Rear Fender, Molding - Scratch - Minimal / Roof - Scratch & Dent - Minimal / (L) Rear Door, Molding - Scratch - Minimal / (L) Step, In-panel, Side Spoiler - Scratch & Dent - Minimal / (L) Mirror - Scratch - Minimal / (L) Front Door, Molding - Dent - Minimal / (L) Front Fender, Molding - Scratch - Minimal / Front Bumper, Grille, Lamps - Crack, Gap - Small / Bonnet, Headlight - Scratch - Minimal</p>
