General Information

Make	Mitsubishi	Model	Montero SPT
YOM	2016	Odo Meter Reading	81,772
Registration No.	DAF7291	Chassis No.	MMBGJK16GH005957
CC	2.4	Transmission	M/T
Fuel Type	Diesel	Type of Body	SUV
Colour	Black

Body / Panel Condition

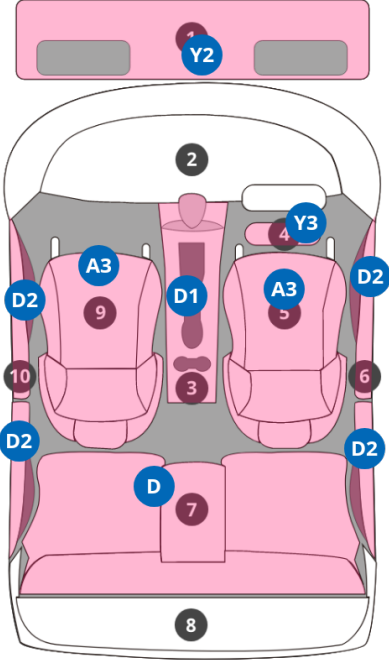
Interior Evaluation : C	Exterior Evaluation : E

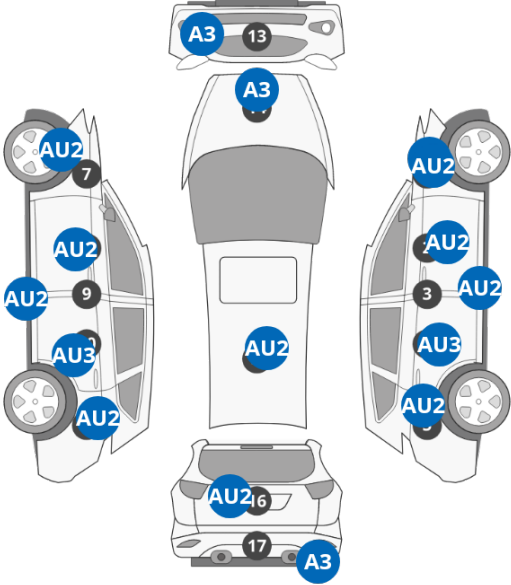
<p>A : Scratch AU : Scratch & Dent B : Modified C : Corrosion G : Stone chip P : Faded S : Rust SC : Rust & Corrosion U : Dent X : Defective Y : Crack, Gap</p>
<p>Remarks (R) Front Seat - Cut, Crack - Medium / (L) Front Floor Mat - Grime - Medium / Rear Seat - Worn - Yes / (L) Front Seat - Cut, Crack - Medium / (L) Front Trim - Worked - Small / (R) Front Trim - Worked - Small / (L) Rear Trim - Worked - Small / (R) Rear Trim - Worked - Small / Console, Switchs, Vents - Worked - Minimal / Ceiling - Grime - Small</p>	<p>Remarks (L) Front Fender - Repair Traces - Yes / (L) Front Door, Molding - Scratch & Dent - Small / (L) Rear Door, Molding - Scratch & Dent - Medium / (L) Rear Fender, Molding - Scratch & Dent - Small / Rear Bumper, Lamps, Panels - Scratch - Medium / (R) Rear Fender, Molding - Scratch & Dent - Small / (R) Rear Door, Molding - Scratch & Dent - Medium / (R) Front Door, Molding - Scratch & Dent - Small / (R) Front Fender, Molding - Modified - Medium / (R) Front Fender, Molding - Scratch & Dent - Small / (R) Step, In-panel, Side Spoiler - Scratch & Dent - Small / Bonnet, Headlight - Scratch - Medium / Front Bumper, Grille, Lamps - Scratch - Medium / (L) Front Fender, Molding - Scratch & Dent - Small / (L) Step, In-panel, Side Spoiler - Scratch & Dent - Small / Roof - Scratch & Dent - Small / Trunk Hood, Rear Gate - Scratch & Dent - Small</p>
