## General Information

<b>Make</b>	Toyota	<b>Model</b>	Avanza
<b>YOM</b>	2025	<b>Odo Meter Reading</b>	9,201
<b>Registration No.</b>	GBK1491	<b>Chassis No.</b>	MHFAA1BY6S0041671
<b>CC</b>	1.3	<b>Transmission</b>	CVT
<b>Fuel Type</b>	Gas	<b>Type of Body</b>	MPV
<b>Colour</b>	Black

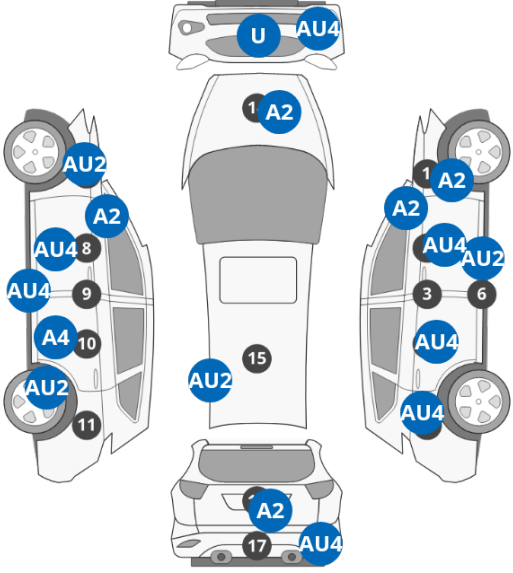
<p><b>A</b> : Scratch <b>AU</b> : Scratch &amp; Dent <b>B</b> : Modified <b>C</b> : Corrosion <b>G</b> : Stone chip <b>P</b> : Faded <b>S</b> : Rust <b>SC</b> : Rust &amp; Corrosion <b>U</b> : Dent <b>X</b> : Defective <b>Y</b> : Crack, Gap</p>
<p><b>Remarks</b> (L) Front Floor Mat - Worked - Small / Ceiling - Grime - Small / Rear Seat - Grime - Large / Mat Other - Grime - Medium / (R) Front Floor Mat - Grime - Large / Sunvisor, Sunglass Holder - Crinkle - Medium</p>	<p><b>Remarks</b> Member (Bolted) - Dent - Yes / (L) Front Fender, Molding - Scratch &amp; Dent - Small / (L) Mirror - Scratch - Small / (L) Front Door, Molding - Scratch &amp; Dent - Large / (L) Step, In-panel, Side Spoiler - Scratch &amp; Dent - Large / (L) Rear Door, Molding - Scratch - Large / (L) Rear Fender, Molding - Scratch &amp; Dent - Small / Trunk Hood, Rear Gate - Scratch - Small / Rear Bumper, Lamps, Panels - Scratch &amp; Dent - Large / (R) Rear Fender, Molding - Scratch &amp; Dent - Large / (R) Rear Door, Molding - Scratch &amp; Dent - Large / (R) Step, In-panel, Side Spoiler - Scratch &amp; Dent - Small / (R) Front Door, Molding - Scratch &amp; Dent - Large / (R) Mirror - Scratch - Small / (R) Front Fender, Molding - Scratch - Small / Front Bumper, Grille, Lamps - Scratch &amp; Dent - Large / Bonnet, Headlight - Scratch - Small / Roof - Scratch &amp; Dent - Small</p>
