## General Information

Date & Time: 16, Feb, 2026 08:26

<b>Make</b>	Toyota	<b>Model</b>	Hilux Tamaraw
<b>YOM</b>	2025	<b>Odo Meter Reading</b>	3,883
<b>Registration No.</b>	HAH9854	<b>Chassis No.</b>	PAHAWAAA4S1340271
<b>CC</b>	2.0	<b>Transmission</b>	M/T
<b>Fuel Type</b>	Gas	<b>Type of Body</b>	Pickup
<b>Colour</b>	White

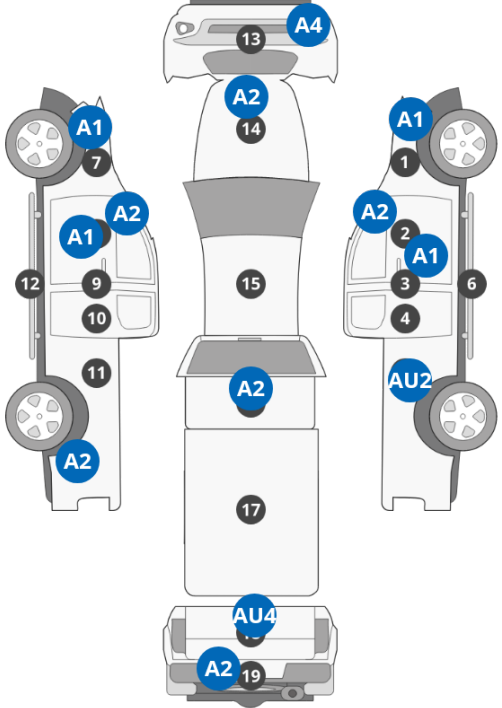
<p><b>A</b> : Scratch <b>AU</b> : Scratch &amp; Dent <b>B</b> : Modified <b>C</b> : Corrosion <b>G</b> : Stone chip <b>P</b> : Faded <b>S</b> : Rust <b>SC</b> : Rust &amp; Corrosion <b>U</b> : Dent <b>X</b> : Defective <b>Y</b> : Crack, Gap</p>
<p><b>Remarks</b> Ceiling - Grime - Small / (L) Front Floor Mat - Worked - Small / (L) Front Seat - Grime - Medium / (R) Front Seat - Grime - Medium / (R) Front Floor Mat - Grime - Small</p>	<p><b>Remarks</b> (R) Mirror - Scratch - Small / (R) Front Door, Molding - Scratch - Minimal / (R) Side Gate - Scratch &amp; Dent - Small / Rear Bumper, Lamps, Panels - Scratch - Small / Rear Gate - Scratch &amp; Dent - Large / (L) Side Gate - Scratch - Small / Cab Back Panel - Scratch - Small / (L) Front Door, Molding - Scratch - Minimal / (L) Mirror - Scratch - Small / (L) Front Fender, Molding - Scratch - Minimal / Front Bumper, Grille, Lamps - Scratch - Large / (R) Front Fender, Molding - Scratch - Minimal / Bonnet, Headlight - Scratch - Small</p>

<p><b>Inspector Notes</b></p>
<p>Scratches on headlight and taillight. Crack on right headlight. Without warranty booklet, jack and tools. With spare tire. 1 key. With LTO plate.</p>
