## General Information

Date & Time: 18, Feb, 2026 12:47

<b>Make</b>	Toyota	<b>Model</b>	Wigo
<b>YOM</b>	2024	<b>Odo Meter Reading</b>	29,641
<b>Registration No.</b>	CCA3057	<b>Chassis No.</b>	MHKAA1BCXPJ006624
<b>CC</b>	1.0	<b>Transmission</b>	CVT
<b>Fuel Type</b>	Gas	<b>Type of Body</b>	Hatchback
<b>Colour</b>	Gray

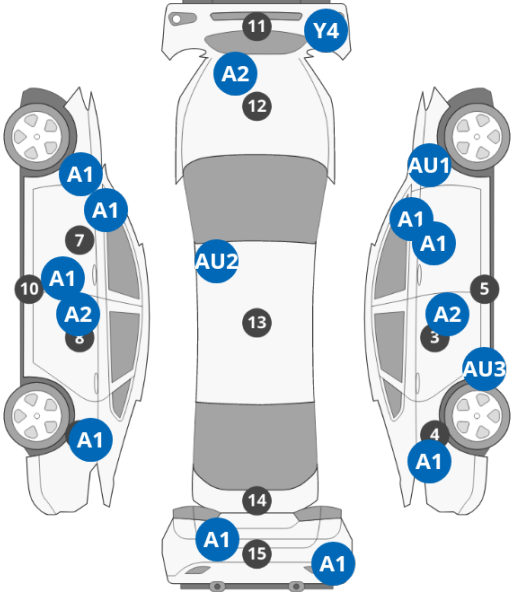
<p><b>A</b> : Scratch <b>AU</b> : Scratch &amp; Dent <b>B</b> : Modified <b>C</b> : Corrosion <b>G</b> : Stone chip <b>P</b> : Faded <b>S</b> : Rust <b>SC</b> : Rust &amp; Corrosion <b>U</b> : Dent <b>X</b> : Defective <b>Y</b> : Crack, Gap</p>
<p><b>Remarks</b> Rear Seat - Grime - Medium / (R) Front Seat - Grime - Medium / (L) Front Seat - Grime - Medium / (L) Front Floor Mat - Worked - Small / Ceiling - Grime - Small</p>	<p><b>Remarks</b> (R) Mirror - Scratch - Minimal / (R) Step, In-panel, Side Spoiler - Scratch &amp; Dent - Medium / (R) Front Fender, Molding - Scratch &amp; Dent - Minimal / (R) Rear Door, Molding - Scratch - Small / (R) Front Door, Molding - Scratch - Minimal / (R) Rear Fender, Molding - Scratch - Minimal / Rear Bumper, Lamps, Panels - Scratch - Minimal / Trunk Hood, Rear Gate - Scratch - Minimal / (L) Rear Fender, Molding - Scratch - Minimal / (L) Rear Door, Molding - Scratch - Small / (L) Front Door, Molding - Scratch - Minimal / (L) Mirror - Scratch - Minimal / (L) Front Fender, Molding - Scratch - Minimal / Front Bumper, Grille, Lamps - Crack, Gap - Large / Bonnet, Headlight - Scratch - Small / Roof - Scratch &amp; Dent - Small</p>
