## General Information

Date & Time: 16, Feb, 2026 15:10

<b>Make</b>	Toyota	<b>Model</b>	Wigo
<b>YOM</b>	2023	<b>Odo Meter Reading</b>	44,954
<b>Registration No.</b>	DBG2632	<b>Chassis No.</b>	MHKA4DF5FNJ076071
<b>CC</b>	1.0	<b>Transmission</b>	A/T
<b>Fuel Type</b>	Gas	<b>Type of Body</b>	Hatchback
<b>Colour</b>	Gray

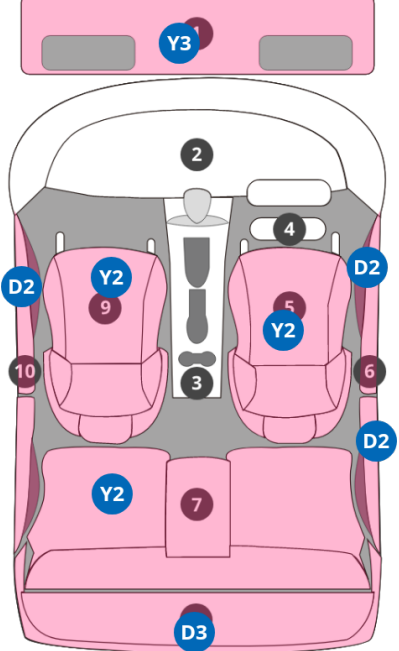
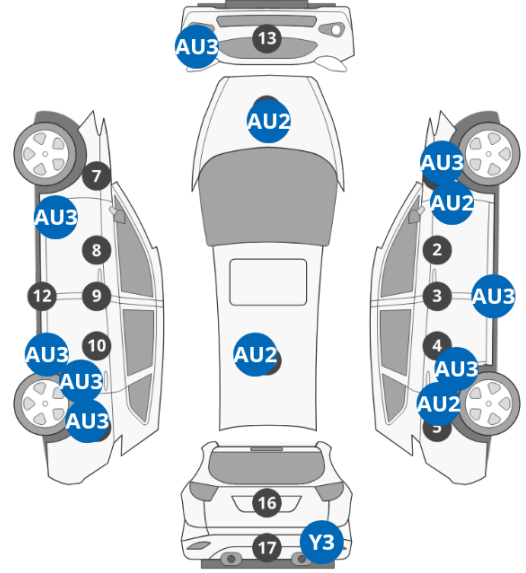
<b>Interior Evaluation :</b>	C	<b>Exterior Evaluation :</b>	E

<p><b>a</b> : Cut, Fray <b>d</b> : Loose, Deformed <b>k</b> : Animal Hair <b>s</b> : Smell <b>t</b> : Cigarette Burns <b>x</b> : Defective <b>y</b> : Stain</p>		<p><b>A</b> : Scratch <b>AU</b> : Scratch &amp; Dent <b>B</b> : Modified <b>C</b> : Corrosion <b>G</b> : Stone chip <b>P</b> : Faded <b>S</b> : Rust <b>SC</b> : Rust &amp; Corrosion <b>U</b> : Dent <b>X</b> : Defective <b>Y</b> : Crack, Gap</p>	
<p><b>Remarks</b> Trunk Room - Loose, Deformed - Medium / (L) Front Trim - Worked - Small / (R) Front Trim - Worked - Small / (R) Rear Trim - Worked - Small / Rear Seat - Grime - Small / (L) Front Seat - Grime - Small / (R) Front Seat - Grime - Small / Ceiling - Grime - Medium</p>		<p><b>Remarks</b> (R) Front Fender - Repair Traces - Yes / (L) Front Fender - Repair Traces - Yes / Roof - Scratch &amp; Dent - Small / (L) Front Door, Molding - Scratch &amp; Dent - Medium / (L) Rear Door, Molding - Scratch &amp; Dent - Medium / (L) Step, In-panel, Side Spoiler - Scratch &amp; Dent - Medium / (L) Rear Fender, Molding - Scratch &amp; Dent - Medium / Rear Bumper, Lamps, Panels - Crack, Gap - Medium / (R) Rear Fender, Molding - Scratch &amp; Dent - Small / (R) Rear Door, Molding - Scratch &amp; Dent - Medium / (R) Step, In-panel, Side Spoiler - Scratch &amp; Dent - Medium / (R) Front Door, Molding - Scratch &amp; Dent - Small / (R) Front Fender, Molding - Scratch &amp; Dent - Medium / Bonnet, Headlight - Scratch &amp; Dent - Small / Front Bumper, Grille, Lamps - Scratch &amp; Dent - Medium</p>

<b>Inspector Notes</b>
with LTO plate, with warranty and manual booklet, with reverse camera, with spare tire, no spare key, no tools and jack, scratches on taillight and headlight.
