General Information

Date & Time: 18, Feb, 2026 13:04

Make	Toyota	Model	Vios
YOM	2025	Odo Meter Reading	11,444
Registration No.	DBT1527	Chassis No.	PA1B18F37S4283454
CC	1.3	Transmission	CVT
Fuel Type	Gas	Type of Body	Sedan
Colour	Red

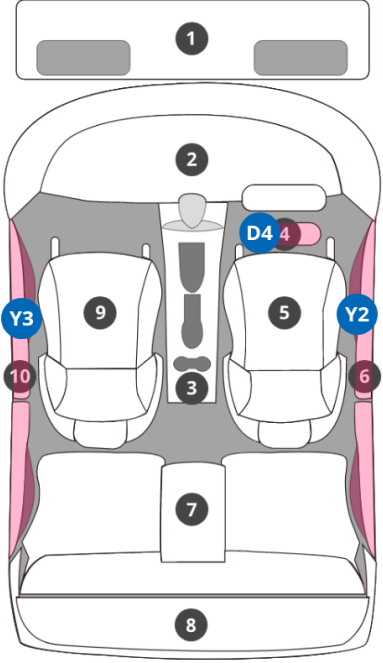
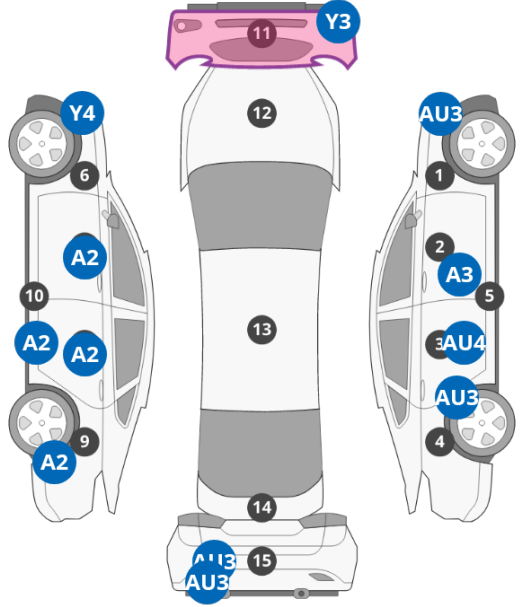
Interior Evaluation :	C	Exterior Evaluation :	E

<p>a : Cut, Fray d : Loose, Deformed k : Animal Hair s : Smell t : Cigarette Burns x : Defective y : Stain</p>		<p>A : Scratch AU : Scratch & Dent B : Modified C : Corrosion G : Stone chip P : Faded S : Rust SC : Rust & Corrosion U : Dent X : Defective Y : Crack, Gap</p>	
<p>Remarks (L) Front Floor Mat - Worked - Large / (L) Front Trim - Grime - Medium / (R) Front Trim - Grime - Small</p>		<p>Remarks (R) Front Door - Repair Traces - Yes / (R) Step - Repair Traces - Yes / (R) Front Fender - Repair Traces - Yes / Bonnet - Repair Traces - Yes / (L) Front Fender - Repair Traces - Yes / (L) Front Door - Repair Traces - Yes / (L) Step - Repair Traces - Yes / (L) Rear Door - Repair Traces - Yes / (L) Rear Fender - Repair Traces - Yes / Trunk Hood, Rear Gate - Repair Traces - Yes / (R) Rear Fender - Repair Traces - Yes / (R) Rear Door - Repair Traces - Yes / Roof - Repair Traces - Yes / Front Bumper, Grille, Lamps - Repair mark - Yes / (R) Front Fender, Molding - Scratch & Dent - Medium / Front Bumper, Grille, Lamps - Crack, Gap - Medium / (R) Front Door, Molding - Scratch - Medium / (R) Rear Door, Molding - Scratch & Dent - Large / (R) Rear Fender, Molding - Scratch & Dent - Medium / Trunk Hood, Rear Gate - Scratch & Dent - Medium / Rear Bumper, Lamps, Panels - Scratch & Dent - Medium / (L) Front Fender, Molding - Crack, Gap - Large / (L) Rear Fender, Molding - Scratch - Small / (L) Rear Door, Molding - Scratch - Small / (L) Front Door, Molding - Scratch - Small / (L) Step, In-panel, Side Spoiler - Scratch - Small</p>
