## General Information

| <b>Make</b> | Toyota | <b>Model</b> | Vios |
| <b>YOM</b> | 2021 | <b>Odo Meter Reading</b> | 46,320 |
| <b>Registration No.</b> | NFI2341 | <b>Chassis No.</b> | PA1B18F30M4152949 |

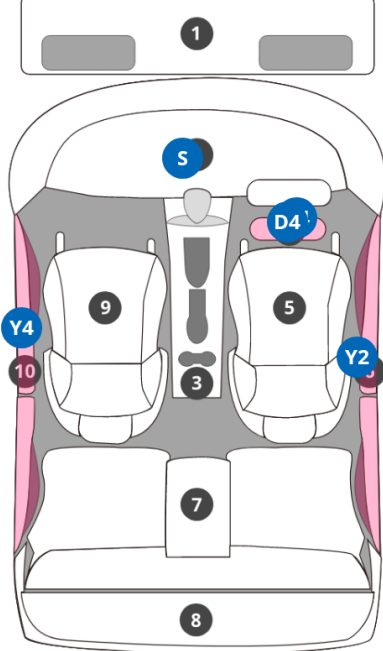
| <p><b>Remarks</b><br/>(R) Front Trim - Grime - Small / (R) Front Floor Mat - Worked - Large / (L) Front Floor Mat - Worked - Large / (L) Front Trim - Grime - Large / Overall Interior - Smell - Yes</p> | <p><b>Remarks</b><br/>Trunk Hood, Rear Gate - Scratch &amp; Dent - Large / Rear Bumper, Lamps, Panels - Scratch &amp; Dent - Large / (L) Rear Fender, Molding - Scratch - Large / (R) Rear Fender, Molding - Scratch &amp; Dent - Large / (R) Rear Door, Molding - Scratch - Large / (R) Front Door, Molding - Scratch - Large / (R) Front Fender, Molding - Scratch - Large / Bonnet, Headlight - Scratch - Large / Front Bumper, Grille, Lamps - Scratch &amp; Dent - Medium / (L) Front Fender, Molding - Scratch - Large / (L) Rear Door, Molding - Scratch - Large / (L) Front Door, Molding - Scratch &amp; Dent - Large</p> |
