## General Information

<b>Make</b>	Toyota	<b>Model</b>	Vios
<b>YOM</b>	2026	<b>Odo Meter Reading</b>	3,171
<b>Registration No.</b>	NJR1218	<b>Chassis No.</b>	PA1B18F37S4297483
<b>CC</b>	1.3	<b>Transmission</b>	CVT
<b>Fuel Type</b>	Gas	<b>Type of Body</b>	Sedan
<b>Colour</b>	Red Mica Metallic

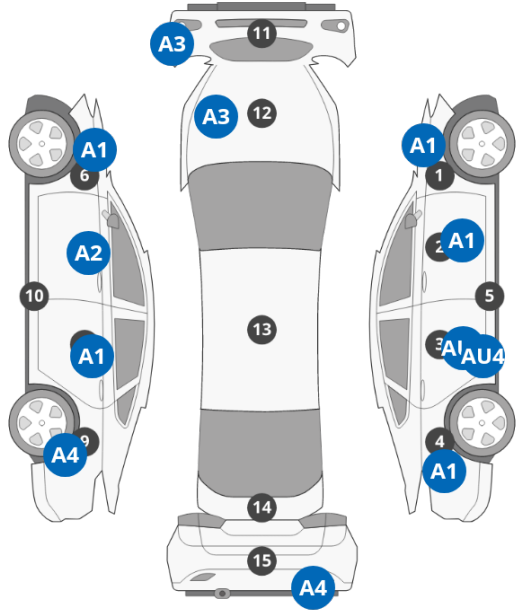
<p><b>A</b> : Scratch <b>AU</b> : Scratch &amp; Dent <b>B</b> : Modified <b>C</b> : Corrosion <b>G</b> : Stone chip <b>P</b> : Faded <b>S</b> : Rust <b>SC</b> : Rust &amp; Corrosion <b>U</b> : Dent <b>X</b> : Defective <b>Y</b> : Crack, Gap</p>
<p><b>Remarks</b> (L) Front Floor Mat - Worked - Small / (R) Front Floor Mat - Worked - Small</p>	<p><b>Remarks</b> (R) Rear Door, Molding - Scratch &amp; Dent - Large / (R) Step, In-panel, Side Spoiler - Scratch &amp; Dent - Large / Rear Bumper, Lamps, Panels - Scratch - Large / (L) Rear Fender, Molding - Scratch - Large / Front Bumper, Grille, Lamps - Scratch - Medium / Bonnet, Headlight - Scratch - Medium / (L) Front Door, Molding - Scratch - Small / (R) Front Fender, Molding - Scratch - Minimal / (R) Rear Fender, Molding - Scratch - Minimal / (L) Front Fender, Molding - Scratch - Minimal / (L) Rear Door, Molding - Scratch - Minimal</p>
