General Information

Make	Toyota	Model	Avanza
YOM	2025	Odo Meter Reading	20,234
Registration No.	NKG7776 - NON - MOVING	Chassis No.	MHFAA1BY4R0032428
CC	1.3	Transmission	CVT
Fuel Type	Gas	Type of Body	MPV
Colour	Green

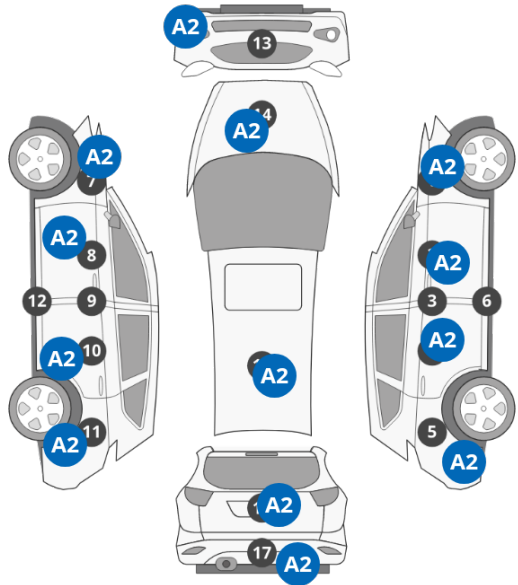
<p>A : Scratch AU : Scratch & Dent B : Modified C : Corrosion G : Stone chip P : Faded S : Rust SC : Rust & Corrosion U : Dent X : Defective Y : Crack, Gap</p>
Remarks Defects not found	Remarks (R) Rear Door, Molding - Scratch - Small / Front Bumper, Grille, Lamps - Scratch - Small / (L) Front Door, Molding - Scratch - Small / (L) Rear Door, Molding - Scratch - Small / Bonnet, Headlight - Scratch - Small / Trunk Hood, Rear Gate - Scratch - Small / Roof - Scratch - Small / (L) Rear Fender, Molding - Scratch - Small / (R) Front Door, Molding - Scratch - Small / (R) Rear Fender, Molding - Scratch - Small / Rear Bumper, Lamps, Panels - Scratch - Small / (R) Front Fender, Molding - Scratch - Small / (L) Front Fender, Molding - Scratch - Small
