General Information

Make	Honda	Model	City
YOM	2019	Odo Meter Reading	78,169
Registration No.	NBS3679	Chassis No.	PADGM6630KV517335
CC	1.5	Transmission	A/T
Fuel Type	Gas	Type of Body	Sedan
Colour	Gray

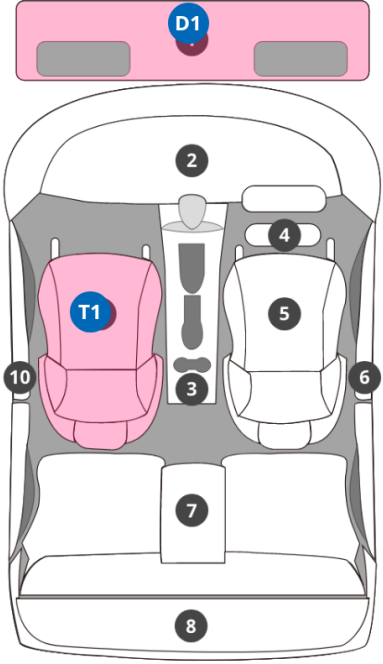
Interior Evaluation : A	Exterior Evaluation : C

<p>a : Cut, Fray d : Loose, Deformed k : Animal Hair s : Smell t : Cigarette Burns x : Defective y : Stain</p>

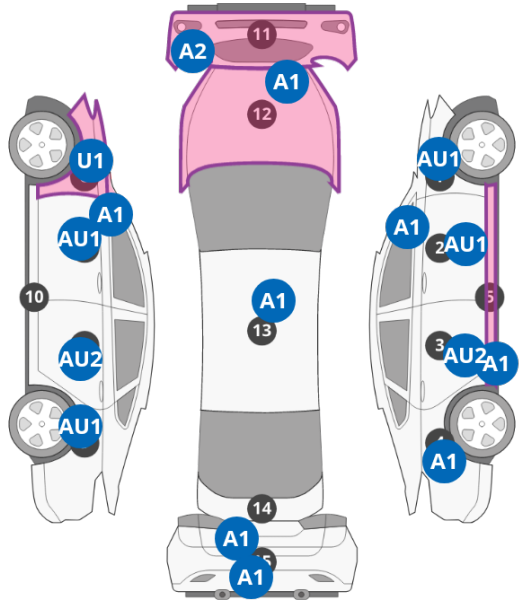
<p>A : Scratch AU : Scratch & Dent B : Modified C : Corrosion G : Stone chip P : Faded S : Rust SC : Rust & Corrosion U : Dent X : Defective Y : Crack, Gap</p>
<p>Remarks (L) Front Seat - Cigarette Burns - Burnt Minimal / Ceiling - Loose, Deformed - Minimal</p>	<p>Remarks (R) Front Door - Repair Traces - Yes / (R) Step - Repair Traces - Yes / (R) Front Fender - Repair Traces - Yes / Bonnet - Repair Traces - Yes / (L) Front Fender - Repair Traces - Yes / (L) Front Door - Repair Traces - Yes / (L) Step - Repair Traces - Yes / (L) Rear Door - Repair Traces - Yes / (L) Rear Fender - Repair Traces - Yes / Trunk Hood, Rear Gate - Repair Traces - Yes / (R) Rear Fender - Repair Traces - Yes / (R) Rear Door - Repair Traces - Yes / Roof - Repair Traces - Yes / Overall Exterior - Full Re-Paint in same color - Yes / (R) Front Fender, Molding - Scratch & Dent - Minimal / (R) Mirror - Scratch - Minimal / (R) Front Door, Molding - Scratch & Dent - Minimal / (R) Step, In-panel, Side Spoiler - Repair mark - Yes / (R) Step, In-panel, Side Spoiler - Scratch - Minimal / (R) Rear Door, Molding - Scratch & Dent - Small / Roof - Scratch - Minimal / (R) Rear Fender, Molding - Scratch - Minimal / Trunk Hood, Rear Gate - Scratch - Minimal / Rear Bumper, Lamps, Panels - Scratch - Minimal / (L) Rear Fender, Molding - Scratch & Dent - Minimal / (L) Rear Door, Molding - Scratch & Dent - Small / (L) Mirror - Scratch - Minimal / (L) Front Door, Molding - Scratch & Dent - Minimal / (L) Front Fender, Molding - Repair mark - Yes / (L) Front Fender, Molding - Dent - Minimal / Bonnet, Headlight - Repair mark - Yes / Bonnet, Headlight - Scratch - Minimal / Front Bumper, Grille, Lamps - Repair mark - Yes / Front Bumper, Grille, Lamps - Scratch - Small</p>
