## General Information

| Make | Toyota | Model | Vios |
| Registration No. | DAR6206 | Chassis No. | PA1B18F35N4183079 |

## Overall Evaluation :

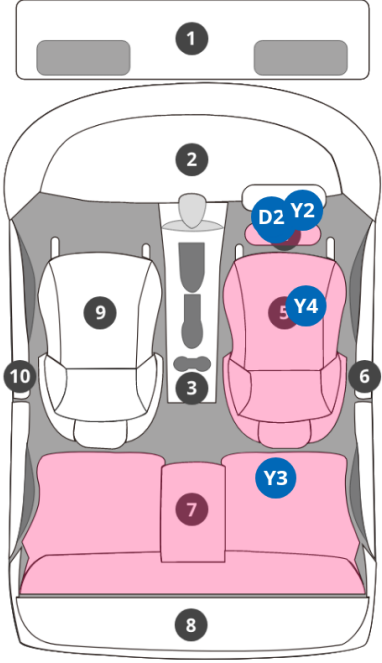
| Interior Evaluation : <b>C</b> | Exterior Evaluation : <b>B</b> |
|---|---|
| <p><b>Remarks</b><br/>Rear Seat - Grime - Medium / (R) Front Seat - Grime - Large / Mat Other - Grime - Medium / (L) Front Floor Mat - Worked - Small / (R) Front Floor Mat - Grime - Small</p> | <p><b>Remarks</b><br/>(R) Front Door, Molding - Scratch - Small / (R) Rear Door, Molding - Scratch - Small / Rear Bumper, Lamps, Panels - Scratch - Minimal / (L) Rear Door, Molding - Scratch - Minimal / (L) Rear Fender, Molding - Scratch - Minimal / Front Bumper, Grille, Lamps - Scratch - Medium / Roof - Rust, Corrosion - Minimal</p> |
