General Information

Make	Nissan	Model	NV350
YOM	2018	Odo Meter Reading	89,257
Registration No.	NEH6166	Chassis No.	JN1TC2E26Z0053589
CC	2.5	Transmission	M/T
Fuel Type	Diesel	Type of Body	Van
Colour	White

Body / Panel Condition

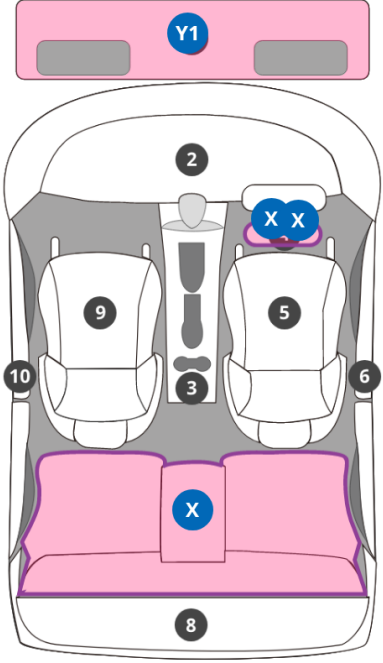
Interior Evaluation : C	Exterior Evaluation : C

<p>a : Cut, Fray d : Loose, Deformed k : Animal Hair s : Smell t : Cigarette Burns x : Defective y : Stain</p>

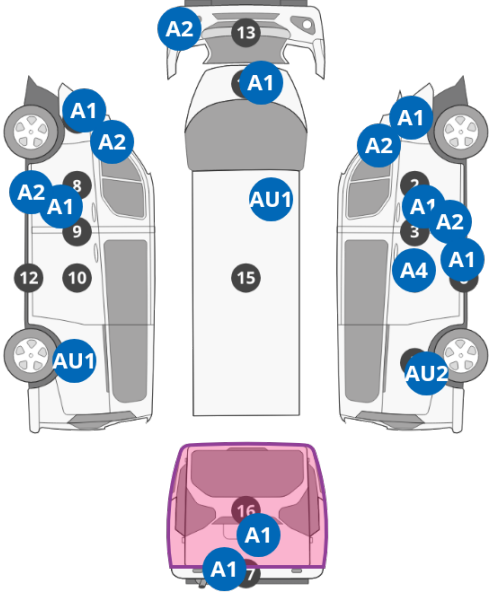
<p>A : Scratch AU : Scratch & Dent B : Modified C : Corrosion G : Stone chip P : Faded S : Rust SC : Rust & Corrosion U : Dent X : Defective Y : Crack, Gap</p>
<p>Remarks (R) Front Floor Mat - Missing - Yes / (L) Front Floor Mat - Missing - Yes / Rear Seat - Partially Missing - Yes / Ceiling - Grime - Minimal</p>	<p>Remarks Trunk Hood, Rear Gate - Repair Traces - Yes / (R) Front Fender, Molding - Scratch - Minimal / (R) Mirror - Scratch - Small / (R) Front Door, Molding - Scratch - Minimal / (R) Rear Door, Molding - Scratch - Large / (R) Center Panel - Scratch - Small / (R) Step, In-panel, Side Spoiler - Scratch - Minimal / Trunk Hood, Rear Gate - Repair mark - Yes / (R) Rear Fender, Molding - Scratch & Dent - Small / Rear Bumper, Lamps, Panels - Scratch - Minimal / Trunk Hood, Rear Gate - Scratch - Minimal / Roof - Scratch & Dent - Minimal / (L) Rear Fender, Molding - Scratch & Dent - Minimal / (L) Mirror - Scratch - Small / (L) Front Door, Molding - Scratch - Minimal / (L) Front Fender, Molding - Scratch - Minimal / Front Panel - Scratch - Minimal / Front Bumper, Grille, Lamps - Scratch - Small / (L) Step, In-panel, Side Spoiler - Scratch - Small</p>
