## General Information

Date & Time: 02, Feb, 2025 10:33

| Make | Toyota | Model | Vios |
| Registration No. | CBM9526 | Chassis No. | PA1B18F37M4154195 |

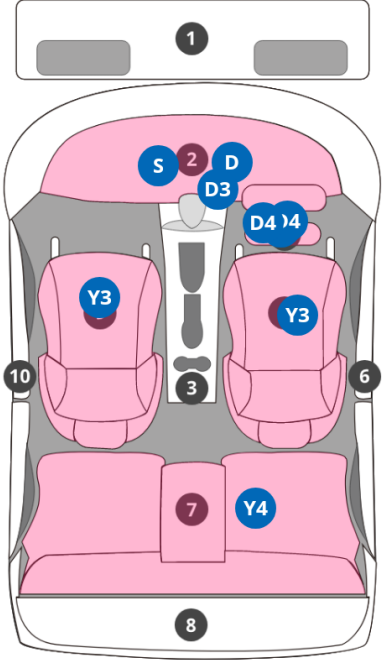
| Interior Evaluation : <span style="color: red; font-weight: bold;">E</span> | Exterior Evaluation : <span style="color: red; font-weight: bold;">E</span> |
| <p><b>Remarks</b></p> <p>Dashboard - Traces of Adhesive Tape - Yes / Rear Seat - Grime - Large / Mat Other - Grime - Large / (R) Front Seat - Grime - Medium / Carpet - Worked - Large / (L) Front Seat - Grime - Medium / (L) Front Floor Mat - Worked - Large / Glove Box - Loose, Deformed - Medium / Overall Interior - Smell - Yes</p> | <p><b>Remarks</b></p> <p>(R) Front Fender - Repair Traces - Yes / Rear Bumper, Lamps, Panels - Scratch &amp; Dent - Large / (R) Rear Fender, Molding - Scratch - Large / (R) Rear Door, Molding - Scratch - Large / (L) Rear Door, Molding - Scratch &amp; Dent - Medium / Front Bumper, Grille, Lamps - Crack, Gap - Large / (R) Front Fender, Molding - Scratch - Medium / Bonnet, Headlight - Scratch - Medium / (L) Front Door, Molding - Scratch - Medium / Roof - Dent - Minimal / (R) Front Door, Molding - Scratch - Medium / Trunk Hood, Rear Gate - Dent - Medium</p> |
