## General Information

<b>Make</b>	Suzuki	<b>Model</b>	Carry
<b>YOM</b>	2024	<b>Odo Meter Reading</b>	40,860
<b>Registration No.</b>	NKC4940	<b>Chassis No.</b>	MHYDC61T0SJ210465
<b>CC</b>	1.5	<b>Transmission</b>	M/T
<b>Fuel Type</b>	Gas	<b>Type of Body</b>	Utility Vehicle
<b>Colour</b>	White

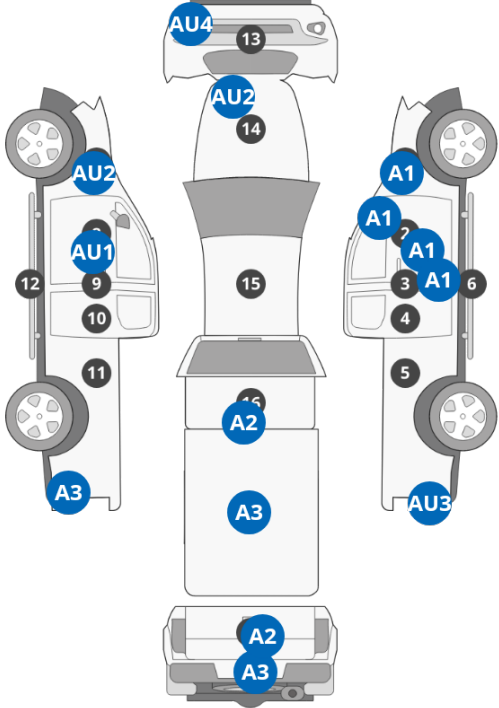
<p><b>A</b> : Scratch <b>AU</b> : Scratch &amp; Dent <b>B</b> : Modified <b>C</b> : Corrosion <b>G</b> : Stone chip <b>P</b> : Faded <b>S</b> : Rust <b>SC</b> : Rust &amp; Corrosion <b>U</b> : Dent <b>X</b> : Defective <b>Y</b> : Crack, Gap</p>
<p><b>Remarks</b> (R) Front Floor Mat - Missing - Yes / (L) Front Floor Mat - Missing - Yes / Rear Seat - Cut, Crack - Small</p>	<p><b>Remarks</b> (R) Front Fender, Molding - Scratch - Minimal / (R) Mirror - Scratch - Minimal / (R) Front Door, Molding - Scratch - Minimal / (R) Center Panel - Scratch - Minimal / (R) Side Gate - Scratch &amp; Dent - Medium / Cargo Bed Floor - Scratch - Medium / Rear Bumper, Lamps, Panels - Scratch - Medium / Rear Gate - Scratch - Small / (L) Side Gate - Scratch - Medium / Roof - Scratch - Small / (L) Front Door, Molding - Scratch &amp; Dent - Minimal / (L) Front Fender, Molding - Scratch &amp; Dent - Small / Front Bumper, Grille, Lamps - Scratch &amp; Dent - Large / Front Panel - Scratch &amp; Dent - Small</p>
